General Aviation Airworthiness Alerts

AC No. 43-16

**ALERT NO. 216
JULY 1996**

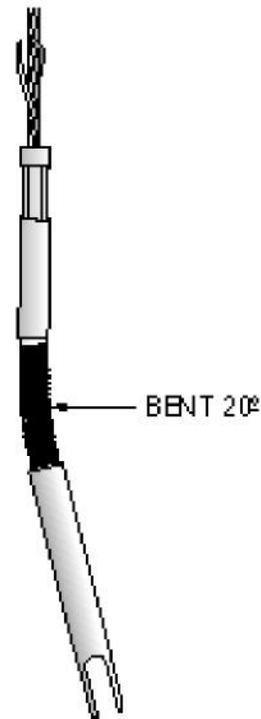
(P/N MS20667-2) was bent in the threaded area. The bend distortion was approximately 20 degrees. This finding prompted an inspection of the right uplock cable, and the same results were found. The submitter speculated this damage was caused by screwing the cable terminal too far into the clevis end fitting, which left the other end with an excessive amount of exposed threads. (Refer to the following illustration.)

During an annual inspection, the left main landing gear uplock cable (P/N 35-815109) was found to have low tension.

Further examination revealed three broken cable strands, and the terminal fitting

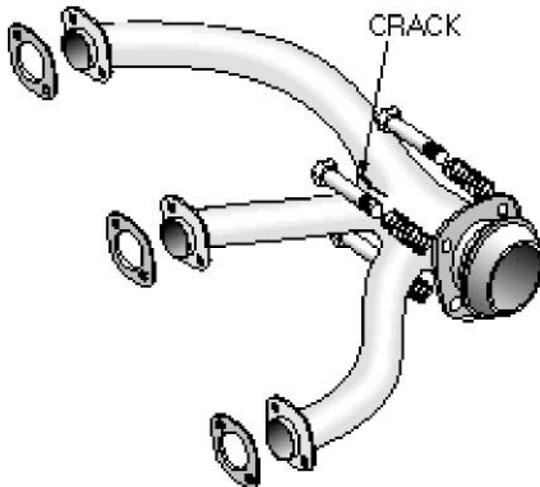
A closer inspection revealed the right exhaust stack (P/N 35-950005-39) was cracked and split. (Refer to the following illustration.) It

appeared the crack originated adjacent to a welded seam and progressed to a split which was approximately 4 inches long and .5 inch wide. The defect was located directly below the area where three cylinders dump into the exhaust stack. The submitter cautioned that unrelated defects may be discovered by paying close attention to the area surrounding the subject of your work.

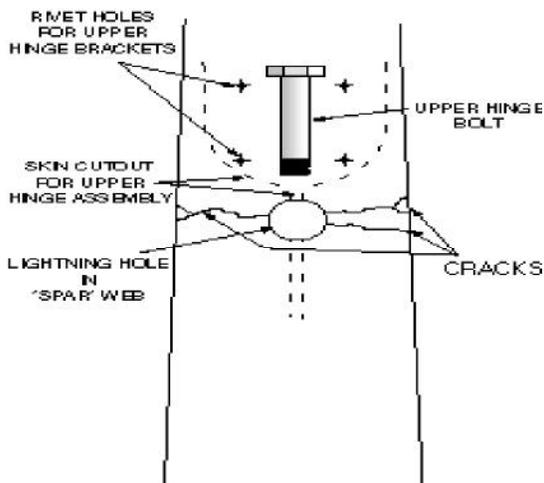
During an annual inspection, the rudder's forward skin was found cracked.

The cracks were located adjacent to the lightning hole at the upper hinge point. (Refer to the following illustration.) This skin (P/N 0433010-6) acts as the forward rudder spar, and this defect seriously compromised the structural integrity of the rudder. The cracks traveled horizontally from both sides of the lightning hole and extended to the bend radius. A review of the service difficulty data base revealed, since March 1991, there have been 15 similar failures reported. The

manufacturer has issued Service Bulletin (SB) SEB 94-3 which deals with this issue. It is recommended that operators of these aircraft review the contents of the SB.

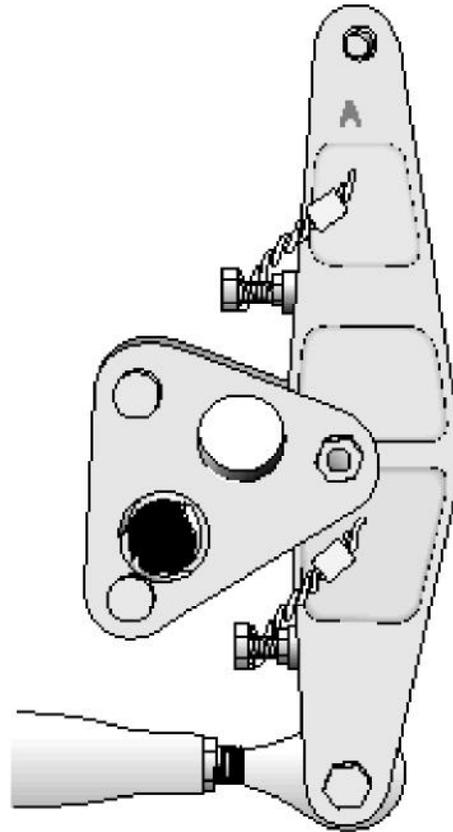
Although the composite wing spar was fractured and separated into numerous pieces, the SU-29 had no evidence of an in-flight breakup. During examination of the remnants of the elevator control system, a bellcrank was found with the upper attaching holes showing no visible deformation and no visible bending of the ears; however, the upper control tube attachment bolt and rod-end were missing. (Refer to the following illustrations.) This bellcrank was the only component of the elevator and aileron control systems that did not display some impact damage. A laboratory examination revealed that, at one time, a bolt had been installed; however, there was no indication a bolt was installed at the time of the accident. The bolt, intended for use in the bellcrank, requires a castellated nut and a cotter key.

BELLCRANK AS FOUND IN WRECKAGE
