# **General Aviation Airworthiness Alerts**

**AC No. 43-16**

**ALERT NO. 231  
OCTOBER 1997**

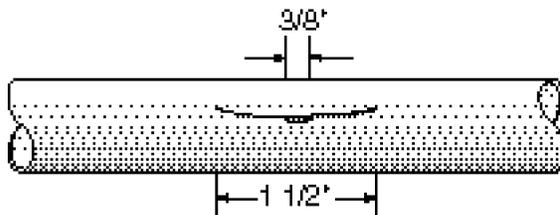
During a 100-hour inspection, the rudder interconnect tube was found chafed and worn.

A screw used to attach the floor panel was excessively long and had worn a hole through the wall thickness of the interconnect tube (P/N 002-410034-3). The hole was approximately .375 inch long, and the tube was scored for a distance of 1.5 inch. (Refer to the following illustration.) Each time the rudder linkage was moved the screw threads wore into the tube. The submitter stated the screw had been installed at the wrong location and was too long. This operator had found this defect on several other aircraft, and the defect was not seen as uncommon. It was suggested that more care be taken to ensure component installation does not interfere with other moving (or stationary) parts.

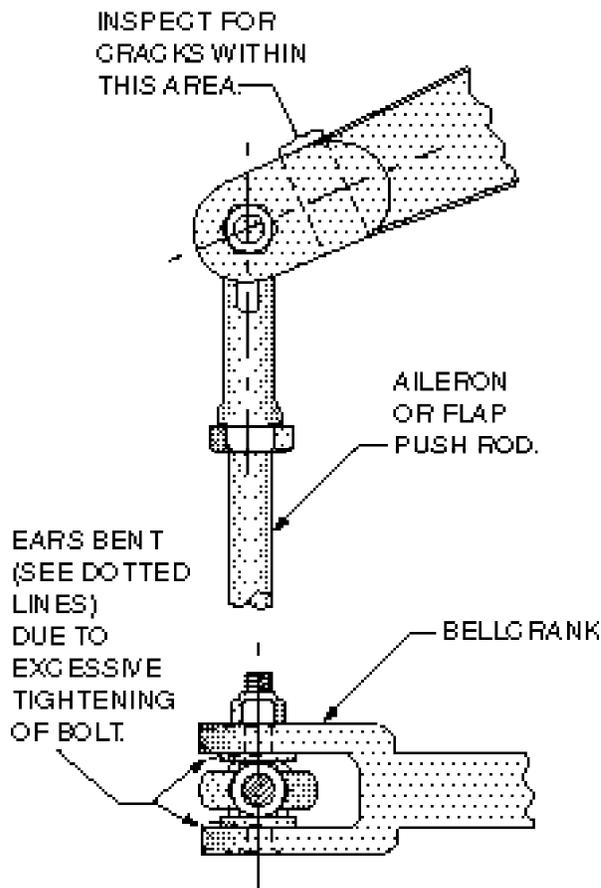
The submitter of this report found cracks in the wing flap and aileron bellcranks. This defect has been found on all of the aircraft models listed.

In some of the aircraft only the wing flap bellcrank was cracked; however, other aircraft had the aileron bellcrank cracked as well. Airworthiness Directive (AD) 49-27-02 and Piper Service Bulletin 109 deal with this subject for PA 12 and 14 series aircraft. They may also contain data useful on the other models previously listed. The cracks usually occur at the flight control or cable attachment ends of the bellcrank adjacent to the attachment hole. (Refer to the following illustration.) The submitter recommended these bellcranks be closely inspected each time the wing covering is removed and after severe wind damage to the wings or flight controls. It was suggested this defect may be caused by overtightening the attachment bolt.

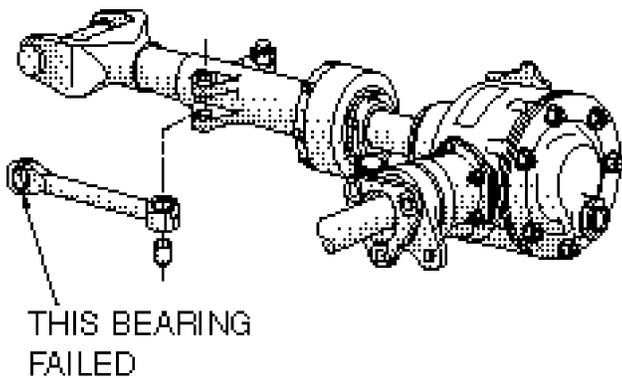
During a daily visual inspection, the bearing in the outboard end of the tail rotor pitch change rod was found almost completely separated from the housing. (Refer to the following illustration.)

The pilot of the previous flight did not notice any abnormalities in the operation of the tail rotor control system. It appeared that the bearing was one flight away from a total failure, which could have resulted in complete loss of the helicopter and its occupants. This operator maintains a large fleet of like aircraft, and this is the second such failure he has experienced. The first occurrence was found as the causal factor during an accident investigation. The pitch change link has been retained for metallurgical analysis and when the results are received, they will be printed in a future edition of this publication.
