Aviation Maintenance Alerts

AC No. 43-16A

**ALERT NO. 240
JULY 1998**

**Improve Reliability-
Interchange Service
Experience**

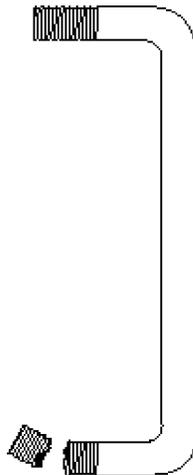
Cessna; Model 182C; Skylane; Defective Main Landing Gear Attachment; ATA 3211

During a scheduled inspection, maintenance personnel discovered the left main landing gear "U-bolt" attachment (P/N 0541153) was broken.

The "U-bolt" attachment was broken on one side in the threaded area. (Refer to the following illustration.) The submitter believed the failure occurred due to metal fatigue and/or possible overtorque of the nut. It was recommended that special attention be given to this part during scheduled inspections and maintenance.

Part total time-4,450 hours.

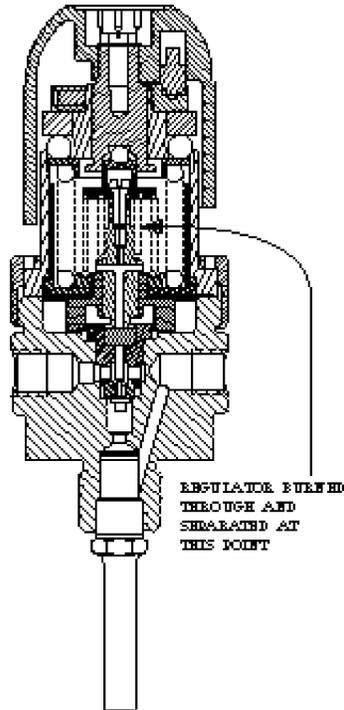
Cessna; Model 525; Citation; Oxygen System Defect; ATA 3500

A mechanic reinstalled an oxygen cylinder (P/N 176274-50) after a hydrostatic test. While refilling the cylinder, he heard a noise that sounded like escaping oxygen. He thought that a fitting was loose and went to get a wrench. When he returned, there was a "pinpoint of green light at the regulator body," and sparks began to fly from the regulator. Due to the ensuing fire, he suffered second-degree burns to his left forearm. Even though the aircraft damage was minor, the potential for complete destruction was present.

Witnesses stated there were two separate explosions, and the fire burned through the outer skin on the nose of the aircraft. The fire was extinguished using a portable fire extinguisher. The oxygen regulator (P/N 172270-01) defaulted internally and trapped approximately 1,600 pounds of pressure in the cylinder which stopped the escape of oxygen. The fire burned a dime-sized hole directly below the oxygen regulator. The excessive heat distorted the aircraft skin in approximately a 6-inch diameter around the hole. The oxygen regulator was burned in half. (Refer to the following illustration.)

Part total time-616 hours.

This mishap was preventable. Attempting to tighten an oxygen system fitting with pressure on the system should never be done. (This applies to all other aircraft systems as well.) After installing the oxygen cylinder, all of the lines and fittings should be double checked for security before any pressure is applied. If a leak is suspected while servicing the system, the oxygen flow should be stopped immediately, and all of the valves should be closed. The pressure should be

relieved before repairing the leak source. Oxygen, in gas or liquid form, is very volatile and poses a serious safety hazard; therefore, it should be handled properly.

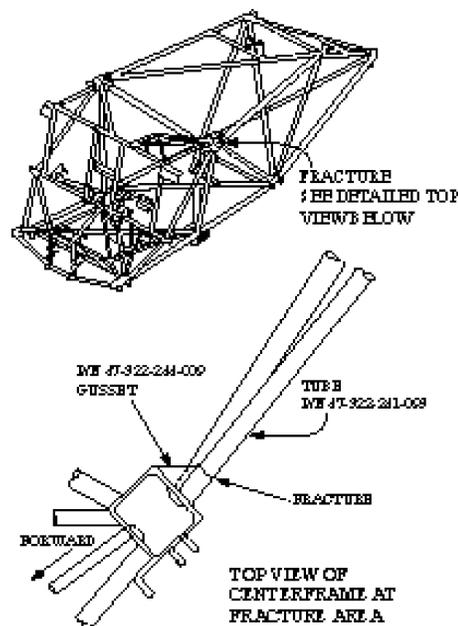
Bell; Model 47G-3B-1; Structural Defect; ATA 5313

During a positioning flight, prior to beginning aerial application work, the tail rotor failed to respond to control inputs. As the helicopter rotated rapidly to the right, the pilot maneuvered to clear a power line and entered an autorotation. The helicopter suffered substantial damage, and the pilot was seriously injured.

An initial inspection revealed that the forward tail rotor drive shaft was disconnected from the transmission. After further examination, it was determined that the tail rotor drive shaft had become disconnected due to an increase in the distance between the forward and aft female couplings. This increase in distance was the result of a fracture in the upper left longeron tube (P/N 47-322-241-143) on the center frame. (Refer to the following illustration.) The fracture was the result of "fatigue cracking" that originated on the tube's inboard side at the toe of a weld for a gusset. This fracture would not have been readily visible during inspections of the helicopter due to its position behind the chemical tank which is mounted on the left side of the fuselage. However, the presence of heavy corrosion and corrosion pitting of the fracture surface suggested that the failure had been developing for some time and should have been discovered by maintenance personnel.

Part total time-5,175 hours. The date of manufacture was 1968.

The findings of this accident investigation suggest this area should receive particular attention during scheduled inspections and maintenance.

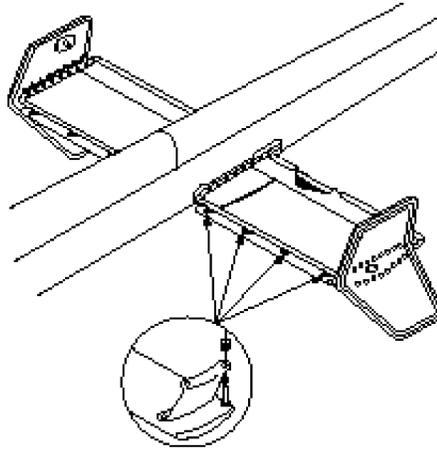
During a postflight inspection, the technician discovered the left slat for the horizontal stabilizer was missing. The slat was installed on the leading edge of the stabilizer to improve airflow conditions at high angles of attack and slow speeds.

At this time, a total of 19 slat supports have been found cracked. It was recommended that special attention be given to this area during both preflight and postflight inspections to preclude the loss of the slat assembly while in flight.

Part total time average is 2,236 hours. This anomaly has not occurred on helicopters with less than 1,700 hours.

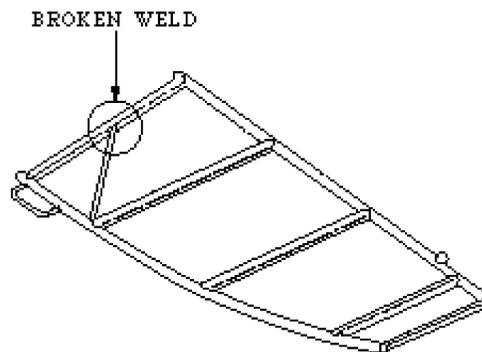
An investigation revealed that the tack weld securing the diagonal brace to the butt rib had broken. (Refer to the following illustration.) From the available evidence, it was apparent that the weld was inadequate. The diagonal brace is not a structural member; however, it provides support to prevent the butt rib from deforming during the fabric covering process.

Part total time-325 hours.

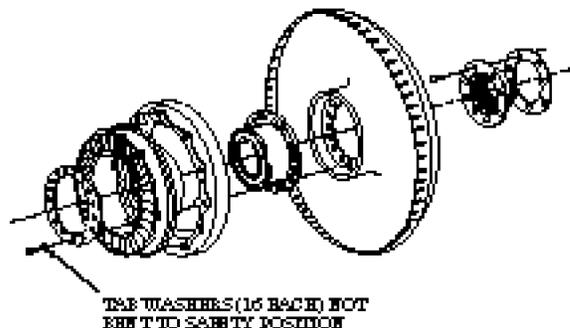
Sixteen bolts with tab washers are used for this installation. The washer tabs had not been bent over to lock the bolts in place. (Refer to the following illustration.) The engine maintenance records did not indicate any maintenance had taken place in this area since the last engine overhaul. It was evident that the washer tabs had been overlooked during overhaul. Thanks to the observant eye of the submitter, this defect was corrected before any damage occurred.

Part total time not reported.
