# **Aviation Maintenance Alerts**

**AC No. 43-16A**

**ALERT NO. 243  
OCTOBER 1998**

**Improve Reliability-  
Interchange Service  
Experience**

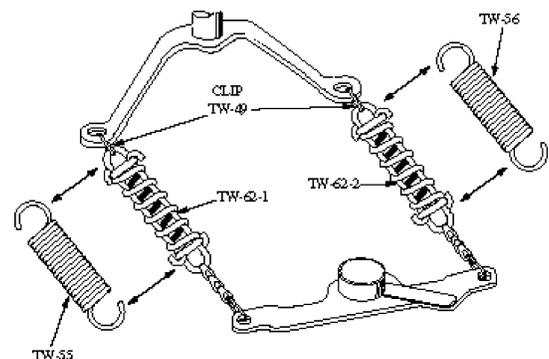
##### **Aeronca; Model 65-CA; Tailwheel Spring Retention Clip Failure; ATA 3220**

Maule Aerospace Technologies, Inc., manufactures the tailwheel assembly. The right tailwheel spring retention clip (Maule P/N TW-49) came loose. The owner/pilot stated this was the second time the right spring retention clip had failed on this aircraft. He offered no probable reason for the disengagement of the spring retention clip. (Refer to the following illustration.)

The submitter stated that it appeared the clip moves and changes position when the pilot uses the rudder and causes the clip to disconnect. The manufacturer is not aware of repeated clip disconnect failures on other aircraft.

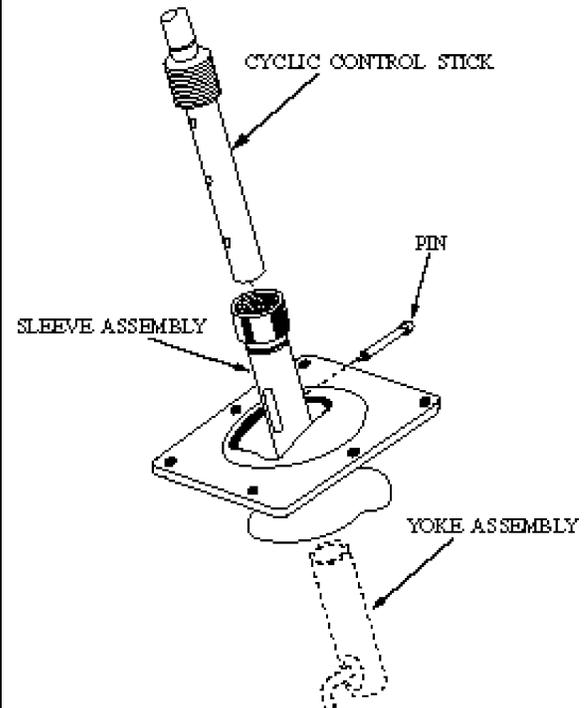
### Kaman; Model K-1200; Defective Cyclic Control Security; ATA 6700

The technician identified the pin as a "quick-removal" pin (P/N K951019-15). The pin secures the cyclic control to the yoke assembly. (Refer to the following illustration.) The technician inspected the system and found severely worn pin-retention balls and a broken plunger (designed to return the balls to the locking position). These defects allowed the pin to vibrate out of position.

Because this condition presents a hazardous situation, the submitter emphasized the importance of removing unserviceable pins from service.
