Aviation Maintenance Alerts

AC No. 43-16A

**ALERT NO. 245
DECEMBER 1998**

**Improve Reliability-
Interchange Service
Experience**

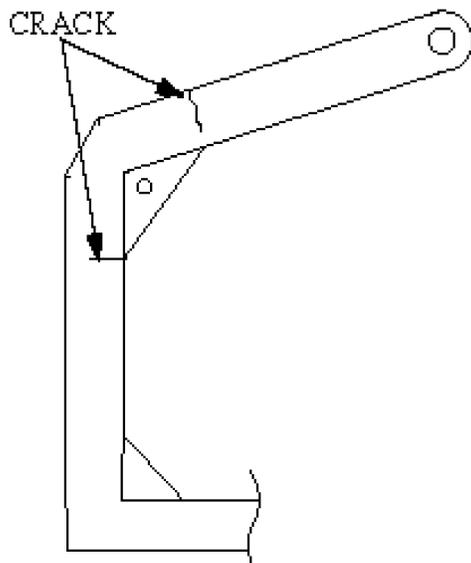
Beech; Model E18S; Flight Control Column Cracks; ATA 2701

During a scheduled inspection, the maintenance technician discovered two cracks in the left flight control column (P/N 404-187500-26).

One crack was on the back of the upper section of the tube just above the bend and traveled around approximately two-thirds of the circumference. The other crack was approximately 1 inch long and was on the front of the control column tube just below the bend. (Refer to the following illustration.) The submitter speculated metal fatigue was caused by the length of service and the "twisting" load applied to the control column.

Part total time-10,243 hours.

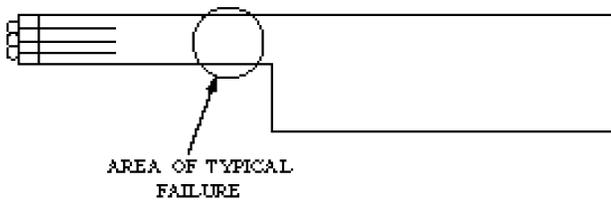
Beech; Model 65 A And B Series; Queen Air; Propeller Deicer Boot Failure; ATA 6112

Technicians discovered the electrical lead wires to the deicer boot (Rapco P/N RA-1288-4) was broken. (Refer to the following illustration.) This reader sent reports of similar failures on 2 other like aircraft. A search through the FAA Service Difficulty Program (SDR) data base revealed three additional failures of this part number deicer boot leads. An interesting side light is that the SDR data base contains reports of 31 propeller deicer boot failures on Beech Model 1900 aircraft.

The deicer boot electrical leads seem prone to break approximately 12 inches from the terminal ends. There are many factors involved with these electrical lead failures: continued and extended exposure to centrifugal and other forces, exposure to temperature extremes, ultra violet light exposure, moisture, etc. Failures usually occur at the weakest point of a part. Therefore, since the failure of these five deicer boots electrical leads occurred at approximately the same location, it seems logical to assume that better security and protection from the elements mentioned

above may solve this problem. One other factor that warrants mentioning is an improvement in the design of the deicer boot in the failure area.

Part total time for the 5 parts was, 540, 1,345, and 438 hours. Two of the reports did not give the time in service.

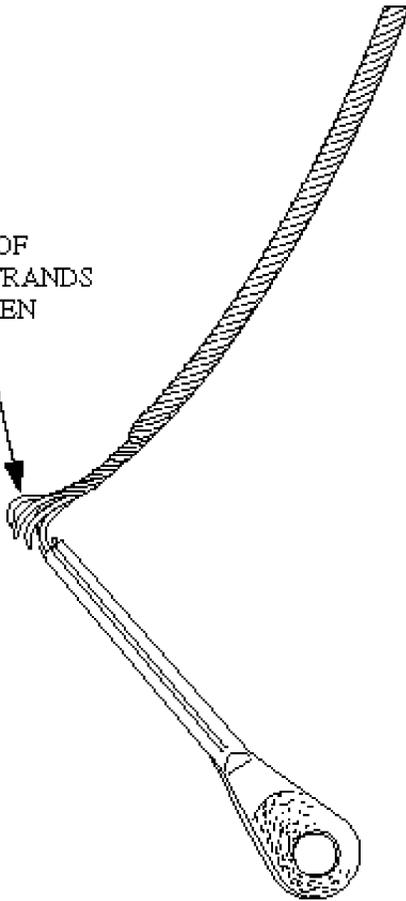
75% OF
CABLE STRANDS
BROKEN

During a scheduled inspection, maintenance personnel discovered a defective right main landing gear strut emergency release cable.

The cable had approximately 75 percent of the strands broken. The cable's damaged area is at the swaged end where it attaches to the gear up-lock mechanism. (Refer to the following illustration.) The submitter filed several other reports concerning this defect on other like aircraft. This cable's failure during flight would prevent the right main landing gear extension. The submitter stated this is a recurring problem and urged the manufacturer implement a solution.

Part total time-1,997 hours.

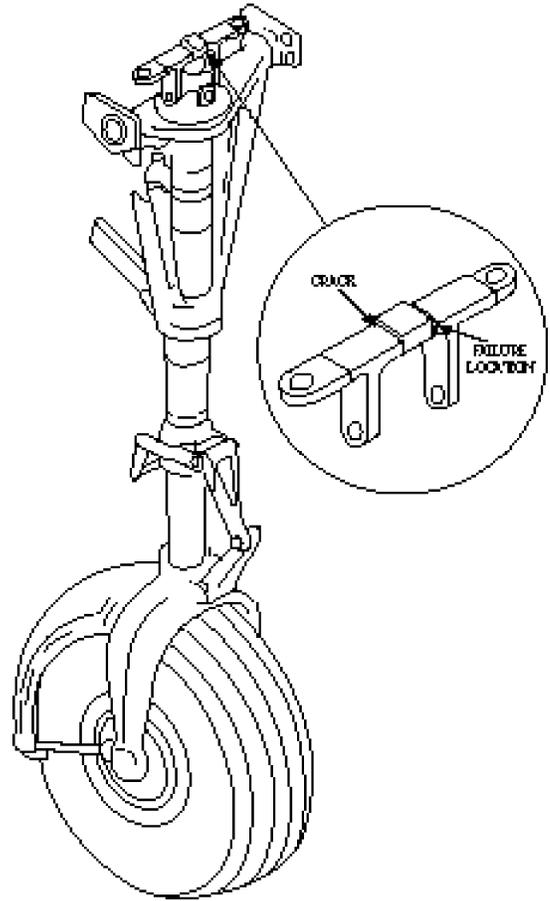
Cessna; Model 402B; Businessliner; Cracked Steering Bellcrank; ATA 3200

During a phase check, the technician discovered a cracked and separated nose wheel steering bellcrank (P/N 5042010-1) pulled away from the rest of the assembly by the steering cable. (See the following illustration.)

Further inspection of the fleet revealed two other "B Model" aircraft with cracks in the same part. The "A and C Model" aircraft in the fleet did not seem to have the problem due to a differently designed bellcrank assembly.

Part total time - 10,976 hours

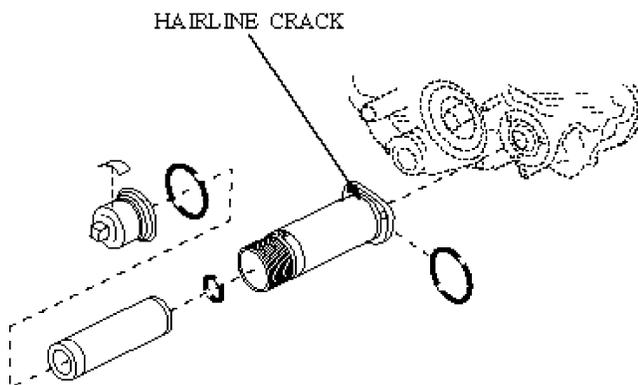
Cessna; Model 650; Citation III; Cracked Oil Filter Housing; ATA 7920

With further investigation, a technician discovered a cracked oil filter housing (P/N 3072231-1) (see the following illustration) as well as a cracked attach bracket (P/N 3071943-1).

Part total time – 2,885 hours

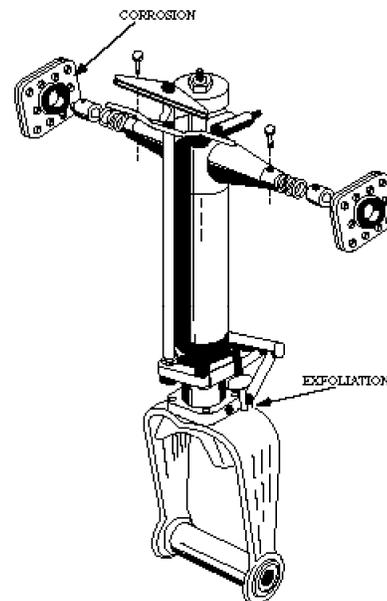
Navion; Model A; Defective Nose Landing Gear; ATA 3222

During an annual inspection, maintenance personnel discovered that the nose landing gear had several serious defects.

There were several manufacturer's service bulletins which had not been complied with concerning the nose gear. The nose gear tire fork (P/N 145-34117) was bent and cracked. Paint "bubbling" was observed on the nose

gear fork and, under 4 layers of paint, severe exfoliation corrosion was found. This part had virtually been consumed by the corrosion process. (Refer to the following illustration.) The left and right trunnion attachment points had excessive vertical and lateral play and both bearings were "worn." The nose gear attachment bolts appeared to be original equipment and many displayed evidence of wear. It was the submitter's opinion that the entire nose gear assembly had never been removed or properly maintained. This report suggested that maintenance personnel complete their inspection responsibilities "by the book" and with a liberal amount of applied "common sense."

Aircraft total time-2,400 hours.

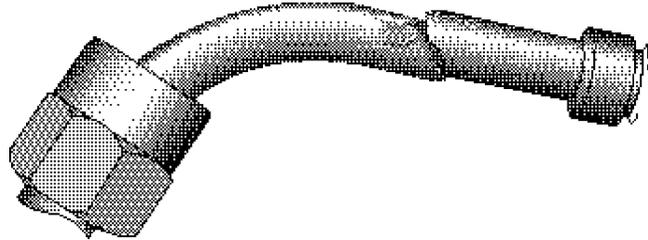
Ratheon; Model 800; Hawker; Pitot Drain Tube Damage; ATA 3411

During a scheduled inspection, maintenance personnel found a severely damaged pitot system drain line.

submitter did not identify the flight control cable or damage it may have received. This area deserves full attention during inspections to ensure properly maintained clearance.

Part total time-4,563 hours.
