# **Aviation Maintenance Alerts**

**AC No. 43-16A**

**ALERT NO. 246  
JANUARY 1999**

**Improve Reliability-  
Interchange Service  
Experience**

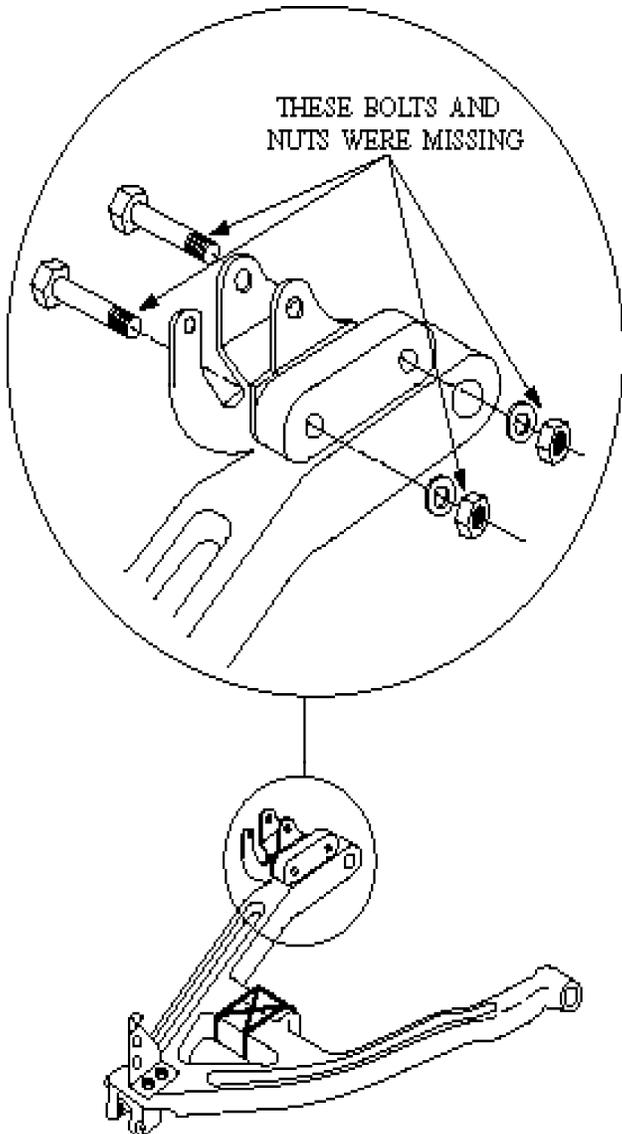
A recent landing accident was attributed to the failure of the nose landing gear to remain "down and locked."

The bolts and nuts that connect the aft drag brace to the nose gear were reported missing. (Refer to the following illustration.) Inspections of other aircraft revealed loose nuts, and in one case the bolt head had separated from the shank. We recommend

The average total time for these inspections was 4,900 hours.

that maintenance personnel inspect this hardware for security and proper torque every 100 hours of operation.

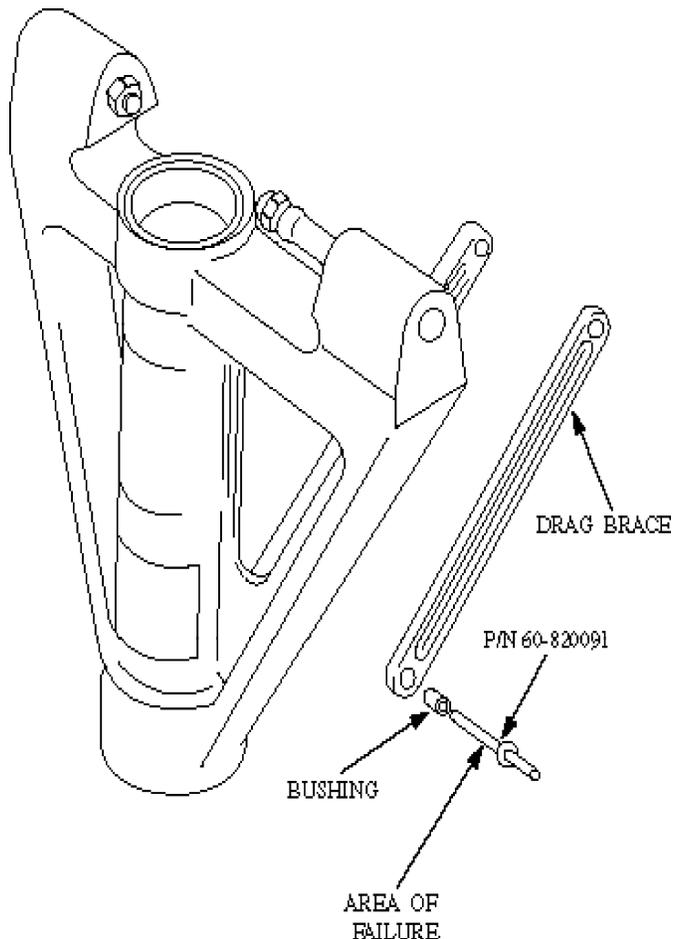
**Beech; Model B60; Duke; Defective Nose Landing Gear Uplock; ATA 3230**

During a post flight inspection, maintenance personnel discovered that the nose landing gear uplock pin was broken.

The uplock pin (P/N 60-820091) also serves as a bolt which secures the lower end of the left lower drag brace. (Refer to the following illustration.) The submitter speculated that this failure was caused by improper adjustment (high tension) of the nose gear uplock mechanism. Metal fatigue, corrosion, and stress were also factors in this failure. It was implied that maintenance personnel had not complied with the manufacturer's required 2,000-hour overhaul time.

Part total time—3,346 hours.

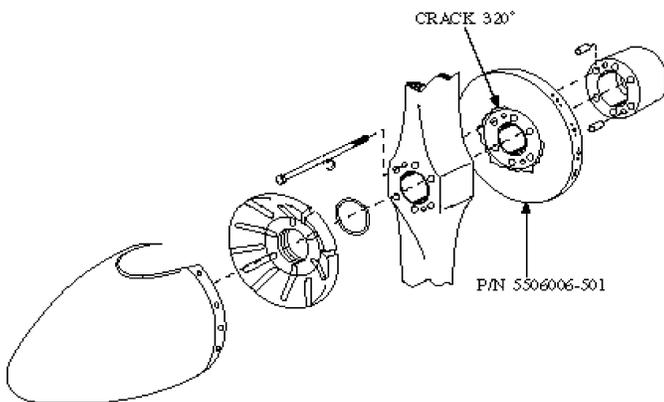
**Gruman American; Model AA-5; Propeller Spinner Cracks; ATA 6113**

When the propeller was removed for installation of a new alternator belt, the maintenance technician found a cracked propeller spinner backing plate.

The crack passed around the mounting holes and traveled through approximately 320 degrees of the backing plate (P/N 5506006-501) circumference. (Refer to the following illustration.) This defect cannot be seen without removal of the propeller and the spacer (P/N B4381). This was the third such failure this submitter discovered. The submitter recommends that the FAA issue an Airworthiness Directive (AD) to require both visual and dye-penetrant inspection of the propeller components.

Part total time—3,268 hours.

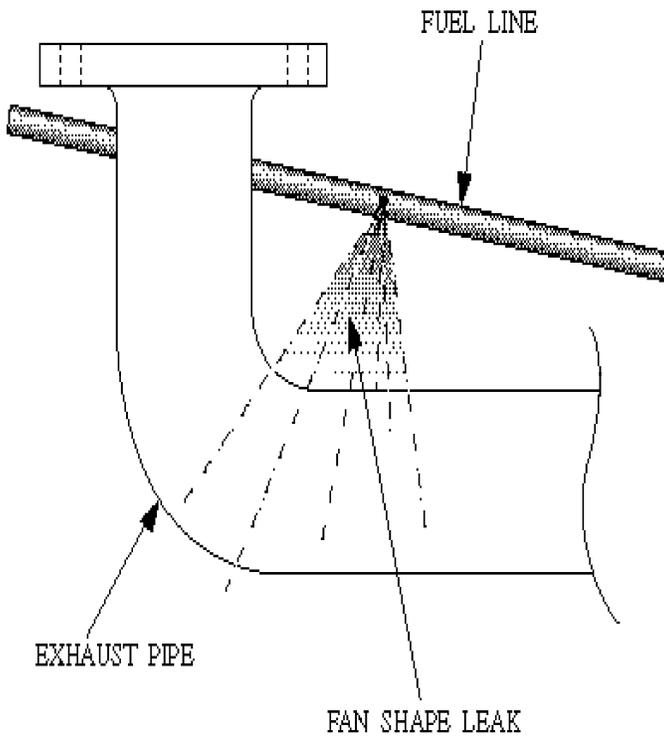
**Mooney; Model M20F; Executive; Fuel Leak; ATA 7310**

Inspection of the engine compartment did not show any apparent leaking. When the technician pressurized the system, a "fan-shaped" pattern of fuel was noted emitting from the fuel line (P/N 303-3) which leads to the cockpit pressure gauge. The specific point of the leak was between the fuel control and the firewall.

The pattern was spraying directly on the engine exhaust pipe. (See the following illustration.) This situation posed a potential for an inflight fire.

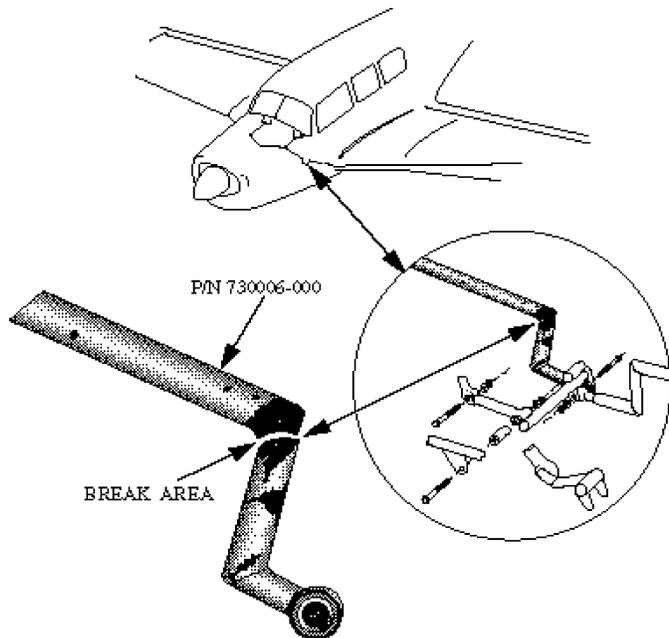
**Mooney; Model M20J; 201; Control Link Failure; ATA 2710**

The pilot noticed sloppy aileron response. He observed the right aileron vibrating excessively and not responding to control inputs. The pilot made a landing without further incident.

Upon inspection, the technician discovered that the right control link rod assembly (P/N 730006-000) was damaged. The point of damage was located below the cabin floor, at the bellcrank. The link had cracked along a factory weld and then through the tubing wall. (See the following illustration.) The break along the weld showed signs of age. The break through the tubing wall seemed more recent.

Inspectors determined that the aileron's limit stops showed no signs of damage and the rest of the aileron system showed no signs of damage or abuse. The replacement part has the same part number, but reinforcement has been added at both 90-degree corners of the link.

Part total time—2,137 hours over 19 years

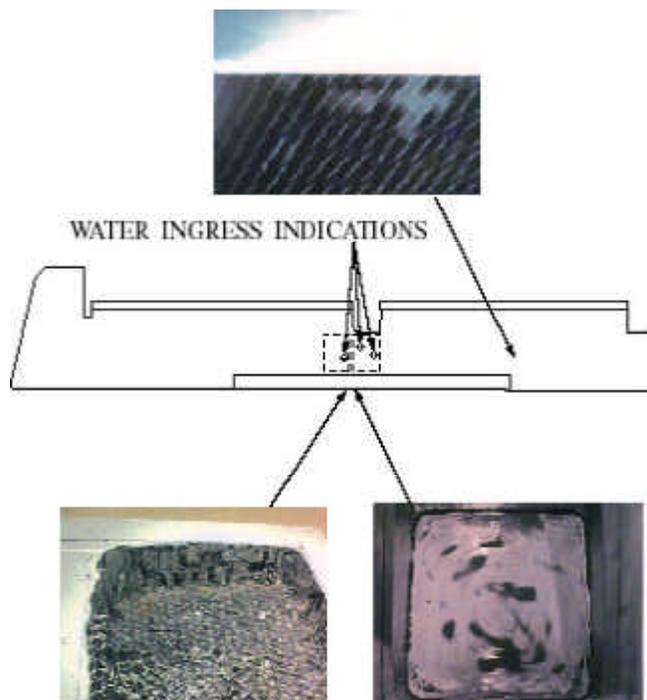
**Raytheon; Model BAE-125-800A; Hawker; Aileron Damage; ATA 5751**

During the repair process, performed in accordance with the manufacturer's technical data, water was not found in the areas indicating water ingress. However, corrosion was found in the honeycomb and lower aileron skin. (Refer to the following illustrations.) In one area pitting corrosion had penetrated the lower aileron skin. The submitter stated that the "x-rays per the Raytheon Non-Destructive manuals are not indicating the presence of

corrosion in the ailerons.” It was suggested that the manufacturer design an alternate method for the detection of corrosion.

Part total time—4,563 hours.

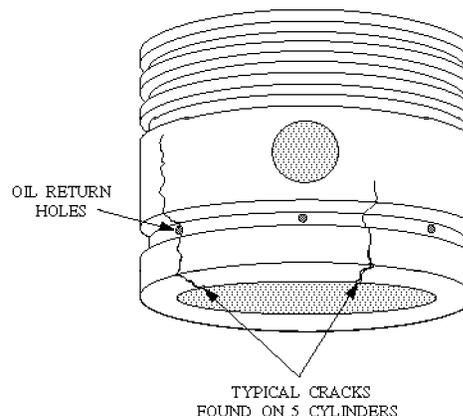
The three remaining cylinders were removed for inspection. A total of five of the six cylinder pistons were cracked. Two of the cracked pistons also had broken rings. The piston cracks appeared to originate at the oil return holes under the ring. The submitter did not offer a conclusion concerning the cause of this damage.

Part total time—680.
