U.S. Department  
of Transportation  
**Federal Aviation  
Administration**

# **Aviation Maintenance Alerts**

**AC No. 43-16A**

**ALERT NO. 248  
MARCH 1999**

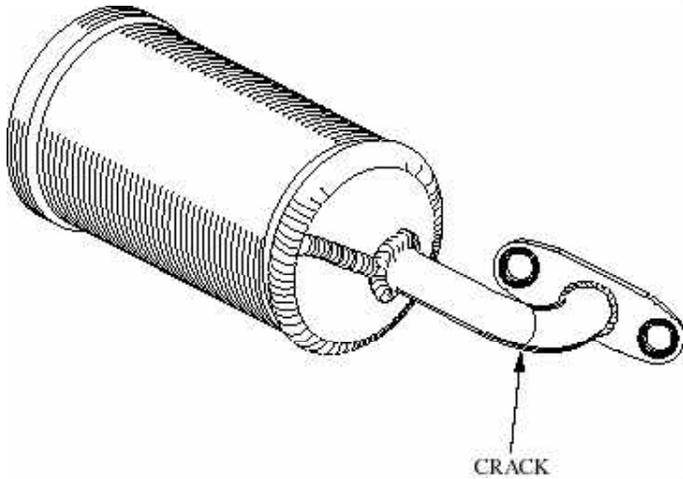
During flight, the pilot noticed a severe engine oil leak. Before engine damage occurred, the pilot made an uneventful landing.

The engine (a Textron Lycoming TIO-540) lost approximately 9 quarts of oil. The oil loss was traced to the turbocharger oil return line located on the lower side of the engine. The oil return line, which runs from the turbocharger to a "can-type" reservoir, was cracked around approximately 300 degrees of its circumference at the point where it makes a 90-degree bend. It appeared the crack began at the outside of the 90-degree bend radius. (Refer to the following illustration.)

The submitter speculated this defect was caused by metal fatigue resulting from vibration. This area deserves special attention during scheduled inspections.

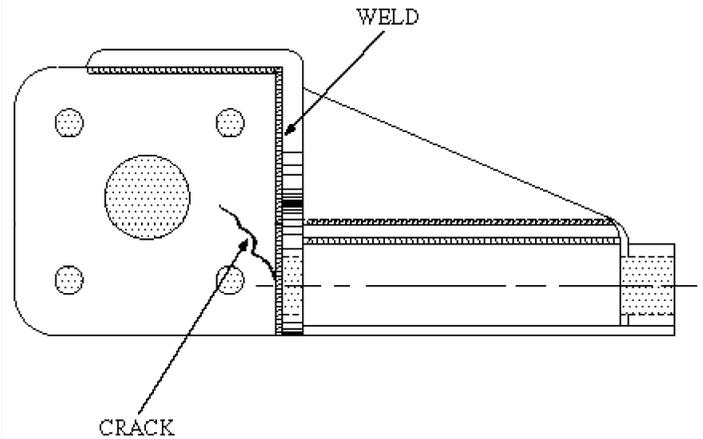
**Cessna; Model P206B; Super Skylane; Defective Alternator Support Bracket; ATA 2410**

During an engine change, the technician found a cracked alternator support bracket.

The crack was approximately 1.25-inches long, and it appeared to originate at a weld. (Refer to the following illustration.) The alternator support bracket (P/N 1250213-15) has been superseded by the manufacturer in accordance with Airworthiness Directive (AD) 79-25-07 and Cessna Service Information Letter SE 79-5. The new part is included in Cessna Service Kit No. SK210-84. The new integral engine mount and alternator support bracket is designed to improve the alternator service life. The old part number support bracket is no longer available from Cessna.

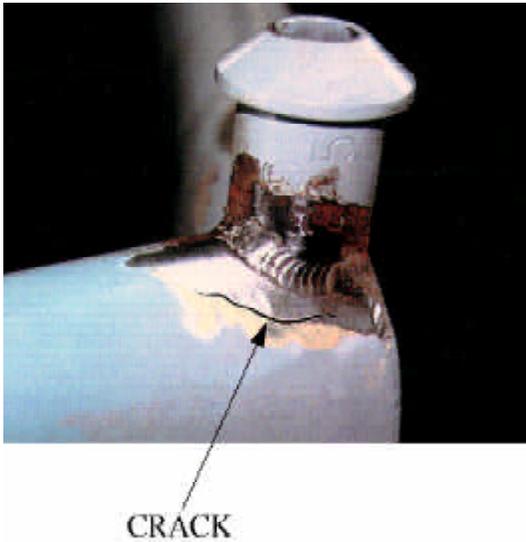
**Cessna; Model 208; Caravan; Engine Mount Ring Damage; ATA 7120**

During a scheduled inspection, a technician found a crack in the engine mount ring assembly (P/N 2651022-15).

The engine mount ring was repaired in accordance with chapter 71 of the manufacturer's maintenance manual. The repair required stop drilling the crack and installing a doubler for reinforcement. Approximately 100 operating hours later, a crack was found on the opposite side of the mount ring. (Refer to the following illustration.) The submitter discovered similar circumstances on another like aircraft.

The FAA Service Difficulty Reporting data base contains five other reports stating similar defects with the engine mount ring. No cause or cure was given for this defect; however, this area deserves your full attention during inspections and maintenance.

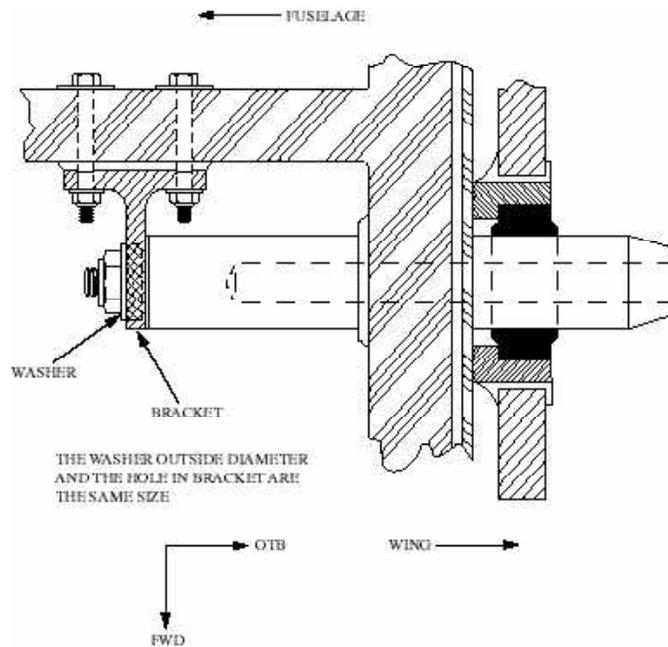
**Diamond; Model DA 20-A1; Katana; Improper Wing Guide "A" Bolt Fit; ATA 5740**

The submitter recommended that all operators inspect this installation to ensure the assembly is correctly installed.

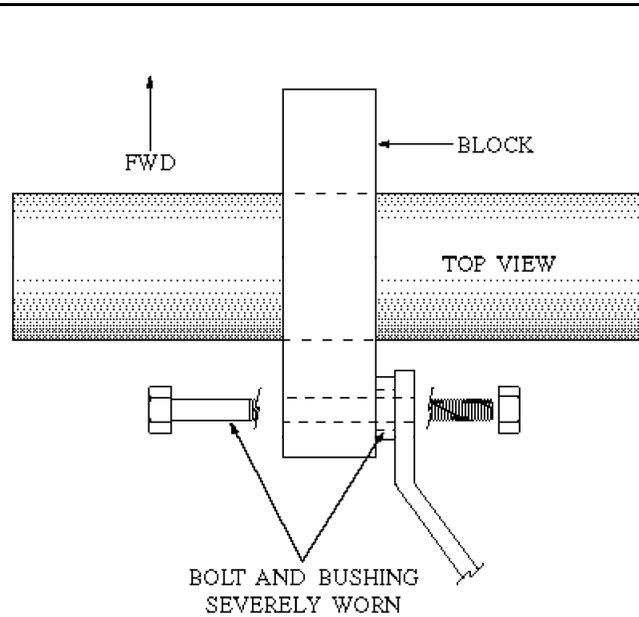
A closer investigation revealed the bearing (P/N 21831-03) and hole in the attachment block for the stabilator tube were worn where they attach to the trim bellcrank (P/N 33972-08). This allowed the trim tab to move which caused movement in the stabilator, and the pilot felt the flutter in the control yoke.

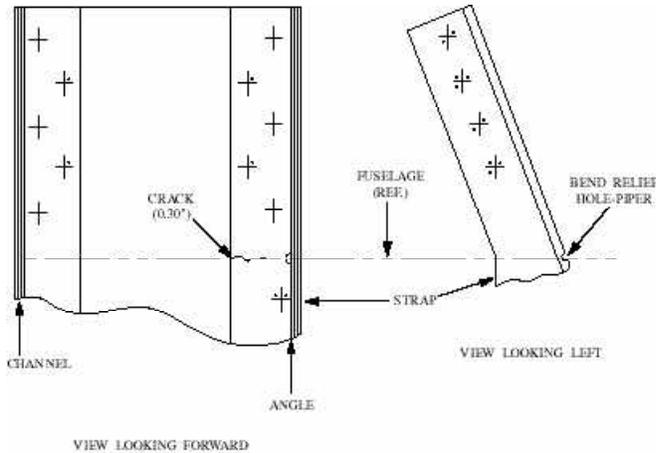
**Piper; Model PA24-250 (PA24); Comanche 250; Cracked Vertical Fin Attach Point; ATA 5553**

During an annual inspection, the technician discovered a 0.3-inch crack in the vertical fin forward attach spar (fuselage) angle (P/N 20749-08). This damage occurred aft of the channel assembly. (Refer to the following illustration.)

Airworthiness Directive (AD) 75-12-06 requires that maintenance inspect the bend-relief holes in this channel and the associated straps (P/N 207-9-506). No cracks were noted in these parts. The aircraft logs show no indication of prior damage to the fin or its attach points.

After the technician installed new parts, the aircraft was returned to service.

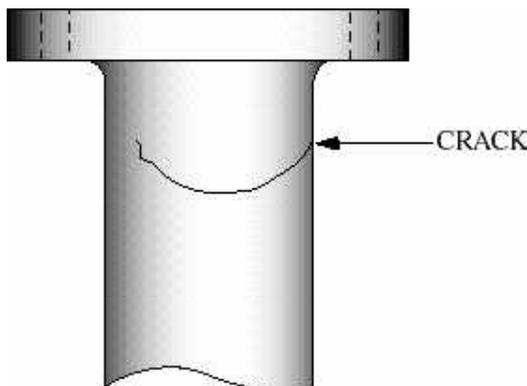
**Piper; Model PA28-140 (P28A); Cherokee; Cracked Exhaust Pipe; ATA 7810**

While in flight, the pilot noted an increase in engine noise. The pilot checked the engine instruments and noted no unusual indications related to the noise. The pilot made a safe landing.

The technician inspected the aircraft for indications of damage or part failure. The technician discovered the no. 1 cylinder's exhaust pipe had cracked at a point where a reinforcement weld secured the exhaust pipe (P/N 63666-02) to the attaching flange. (Refer to the following illustration.)

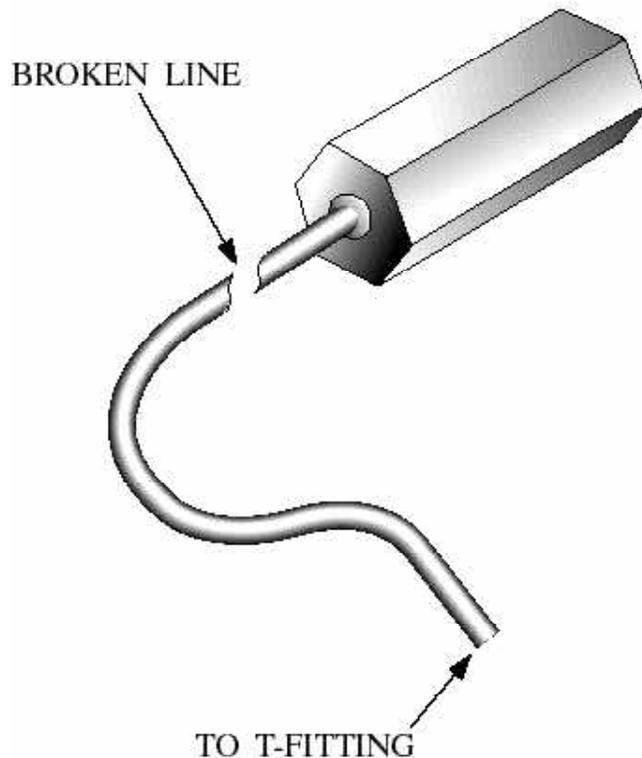
#3 CYLINDER  
(INJECTOR NOZZLE)

After a report of a rough running engine, the top cowling was removed to reveal the no. 3 cylinder fuel injection line (P/N LW12098-0-100) had broken away from the weld which attached the line to the fitting. (Refer to the following illustration.)

The technician discovered the fuel line had chafed a hole in the no. 4 cylinder's oil return line. Also, the no. 2, no. 4, and no. 6 cylinders' fuel injection fittings were loose and in need of tightening.

The submitter speculated the probable cause of the break was harmonic vibration due to inadequate clamping of the line.

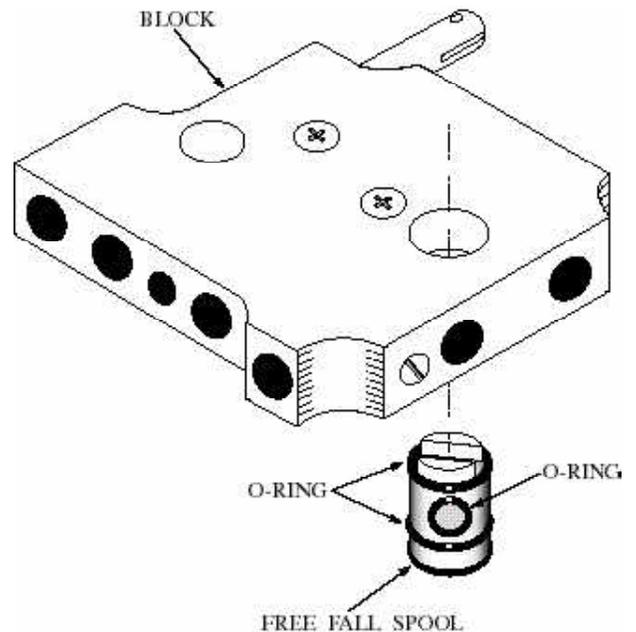
The maintenance technician placed the aircraft on jacks, and the landing gear was cycled. In the process, the pressure reduced to only 600 pounds per square inch. The landing gear valve assembly (P/N 83767-02) was repaired; however, during the flight check, the same problem occurred. (Refer to the following illustration.) The valve assembly was disassembled again and checked more closely. The inspection revealed the "o-ring" had ruptured. The submitter speculated the rupture was caused by burrs on the sides of the hole that the "o-ring" came in contact with during operation.

The submitter suggested better quality control to eliminate burrs and improve the quality of the "o-ring" material.

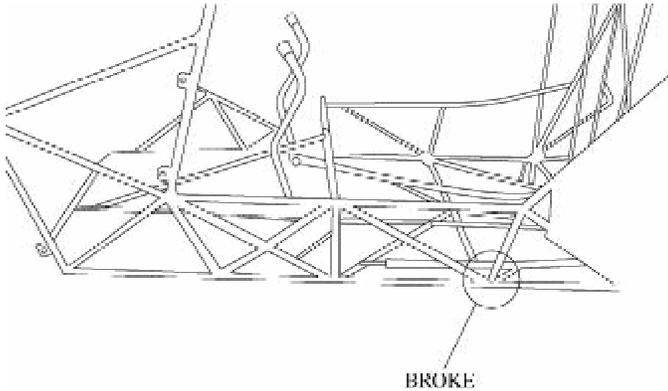
**Kitfox II; Fuselage Structural Failure; ATA 5311**

The available evidence indicated that excessive heat had been used during the welding process, and hydrogen embrittlement adjacent to the weld caused this failure.
