Aviation Maintenance Alerts

AC No. 43-16A

**ALERT NO. 250
MAY 1999**

**Improve Reliability-
Interchange Service
Experience**

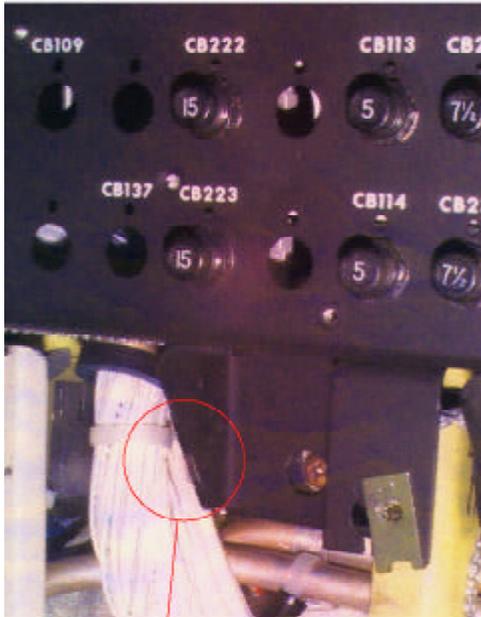
CHAFING POINT

While installing avionics equipment and wiring, a wire bundle was found chafing hard against the lower circuit breaker panel.

The wire bundle went to the copilot's circuit breaker panel and was chafing against the lower forward circuit breaker panel mount. (Refer to the following illustration.) The individual wires in the bundle had not yet chafed through the insulation due to the low number of operating hours. Another like aircraft was found, prior to this finding, with several of the individual wires chafed through the insulation. In this case, the aircraft had 150 hours of operating time. In both cases, it was necessary to reposition the wire bundle to provide sufficient clearance from the circuit breaker panel mount. The submitter recommends that all operators of like aircraft

check this area as soon as possible to prevent a very hazardous electrical failure and smoke in the cockpit.

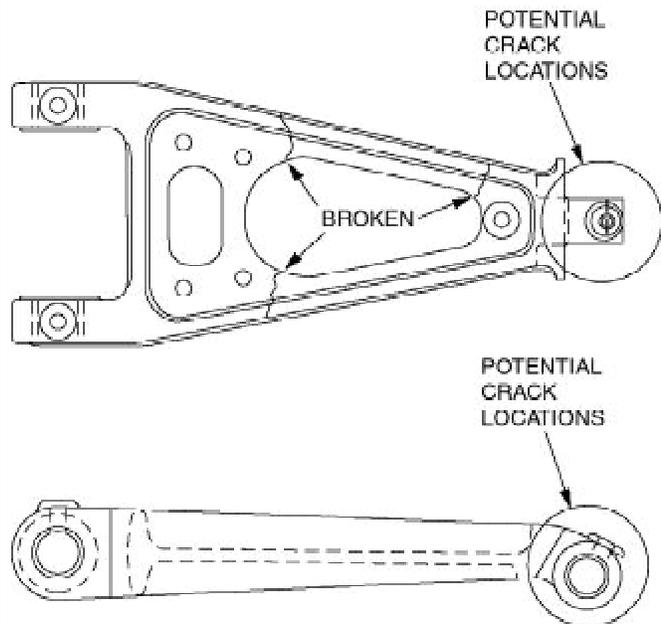
Beech; Model C90; King Air; Main Landing Gear Failure; ATA 3213

During an after-landing rollout, the aircraft pulled to the right and traveled off of the runway. There was no further aircraft damage or personal injury.

Beech Service Bulletin (SB) 32-3134 addresses this subject and was complied with 5 months prior to this occurrence. This failure occurred at a different location than that shown in SB 32-3134. The submitter stated that the

manufacturer will soon issue steel replacement parts for the aluminum torque knee assembly.

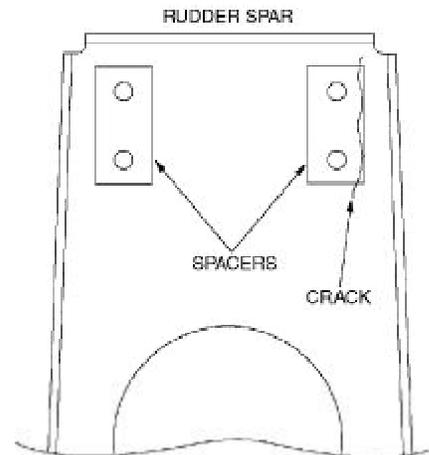
During the annual inspection, the technician discovered the rudder spar (P/N 44228-3) was cracked on the edge of the aluminum spacer which is mounted on the underside of the top rudder hinge. (Refer to the following illustration.)

The submitter stated the crack originated as a result of flexing in that area. Under normal inspection practices, the area is difficult to see and may continue to go unnoticed if the rudder is not removed during other maintenance procedures.

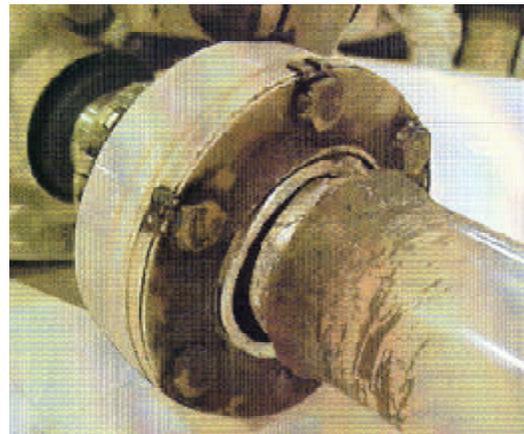
American Eurocopter (Aerospatiale); Model 350B2; Ecureuil; Tail Rotor Spider Assembly Failure; ATA 6720

pedals moved slightly; however, a successful run-on landing was made on a hard surface runway. There were no personal injuries, and the aircraft was not damaged.

An examination revealed the tail rotor rotating spider assembly (P/N 350A33-2129-00) was completely severed, and the tail rotor was being driven by the pitch change links. (Refer to the following illustration.) The spider assembly bearing (P/N 6010-2RS1MT33CA) apparently seized and cut through the rotating spider. American Eurocopter Mandatory Service Bulletin (SB) 05.00.29, dated 99-05, which deals with the tail rotor hub pitch change spider plate bearing check, was complied with 22 flight hours and 10 days prior to this failure. The rotating spider assembly was removed and sent to the manufacturer for further evaluation.
