Aviation Maintenance Alerts

**ALERT NO. 251
JUNE 1999**

**Improve Reliability-
Interchange Service
Experience**

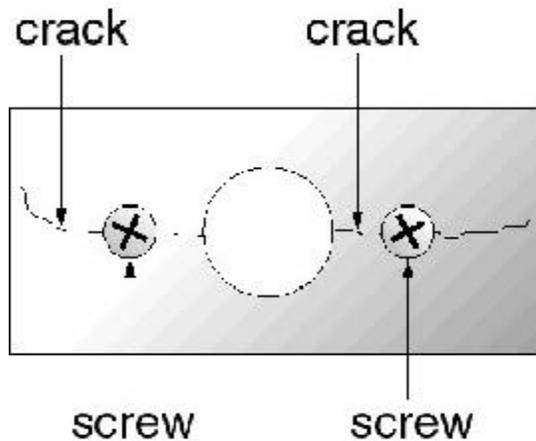
Beech; Model A100; King Air; Doorframe Structural Cracks; ATA 5260

During a scheduled inspection, the technician discovered cracks in the "air stair" doorframes.

It appeared the cracks originated from the hole in the frames (P/N's 50-430043-865 and -867) where the upper latch bolts pass

through. The cracks migrated through the two screw holes adjacent to the latch bolt and continued up the frames. (Refer to the following illustration.)

This area deserves special attention during inspections and maintenance.

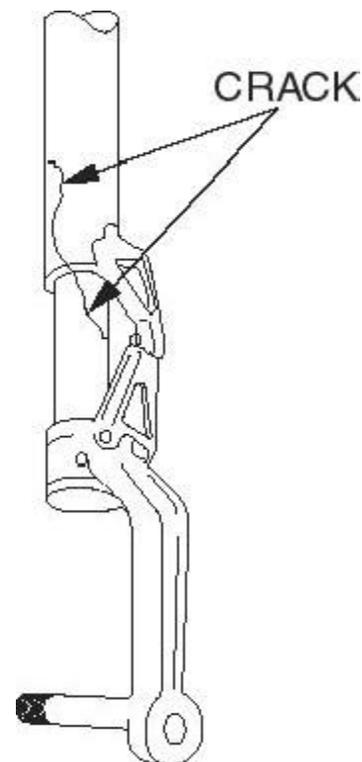
Bellanca; Model 17-30; Viking; Main Landing Gear Failure; ATA 3213

An investigation revealed the lower main gear segment (P/N 194096) failed at the lower scissors attachment point. (Refer to the following illustration.) When the scissors attachment failed, the lower strut and wheel assembly were allowed to rotate freely. Both sections of the strut were cracked; however, the submitter speculated the crack was a consequence of the scissors attachment failure.

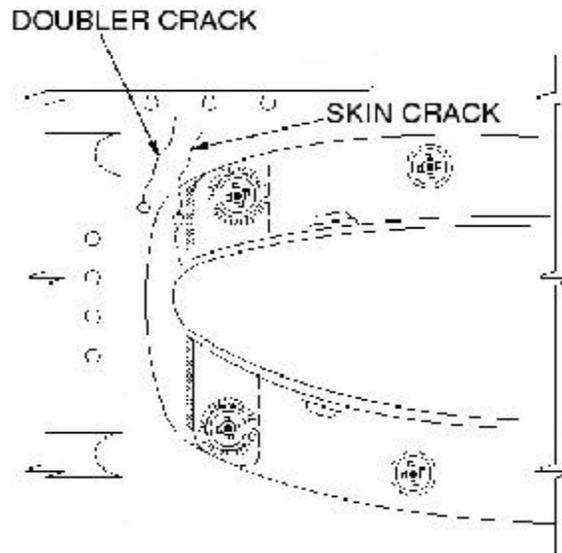
These were original parts, and both cracks emanated from rivet holes. The cause of this defect could not be determined. The submitter suggests giving this area close attention.

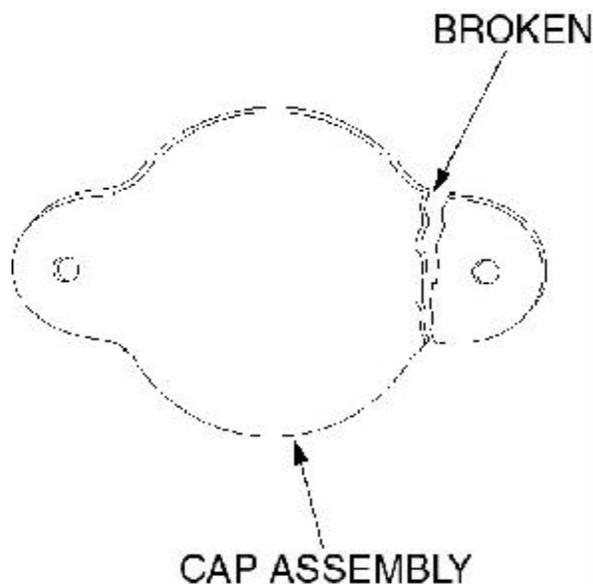
An investigation revealed one of the mounting ears for the engine oil filter housing cap (P/N 6898661) was broken. (Refer to the following illustration.) This allowed engine oil pressure to push the cap up past the "O-ring" seal. The oil filter housing is located on top of the engine. When the oil leaked and contacted the turbine section of the engine, the oil ignited.

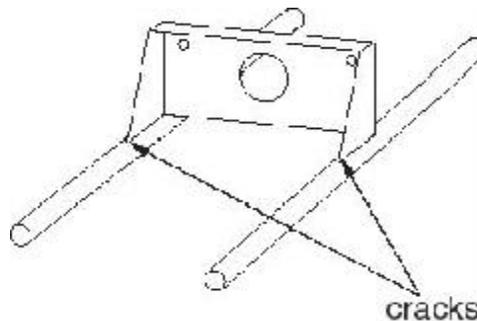
In-flight failure of the horizontal stabilizer may result in a fatal accident, and we urge all operators to ensure this structure is adequate to endure in-flight stress and air loads.
