# Aviation Maintenance Alerts

**AC No. 43-16A**

**ALERT NO. 258  
JANUARY 2000**

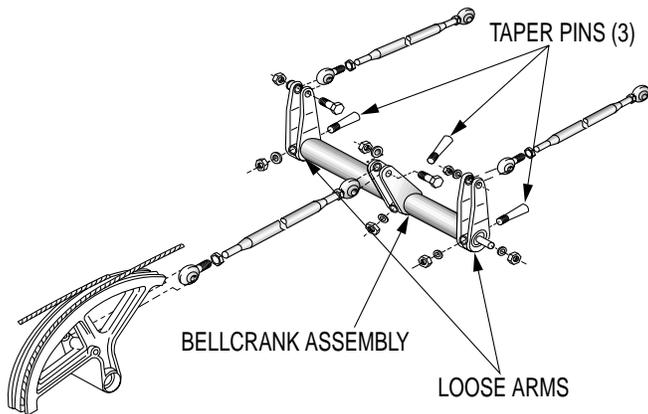
**Beech; Model C-99; Airliner; Elevator Bellcrank Defect; ATA 2730**

The technician traced the "free play" to the elevator bellcrank assembly where the taper pins (P/N 115-524046-3), used to secure the control arms, were loose on the shaft. (Refer to the following illustration.) The technician could not tighten the taper pins without running out of the head-depth clearance required by the maintenance manual. According to the submitter, the aircraft manufacturer drilled oversized taper pin

holes during assembly. The submitter also expressed concern for the cost of this part and the short lifespan.

Part total time-300 hours.

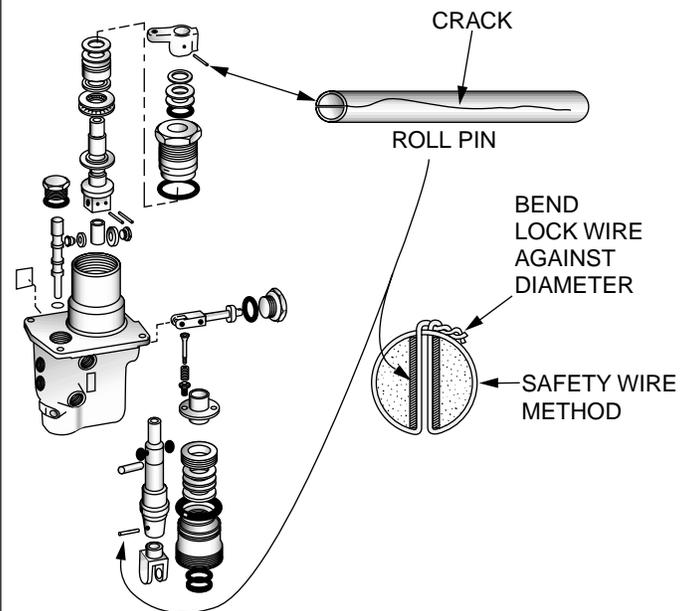
### Pins BAE; Model 41; Jetstream; Defective Steering Selector Roll; ATA 3251

During a scheduled inspection, the maintenance technician discovered a defect in the nose steering selector output shaft roll pin.

The roll pin cracked laterally, and the technician could not remove it by hand pressure. (Refer to the following illustration.) The roll pin (P/N ADS312A83) is used to secure the steering selector (P/N AIR86012/4) output shaft to the nose gear. If the roll pin had migrated out of position, loss of directional control would have resulted.

Part total time not applicable.

The submitter suggested that all operators inspect their aircraft and safety wire the steering selector roll pins in accordance with the applicable SB, if safety wire is not already installed. He discovered a similar crack in the steering selector input shaft roll pin (P/N ADS312/A62). The submitter stated that it is not uncommon to find this defect and suggested checking the roll pins during each scheduled inspection.

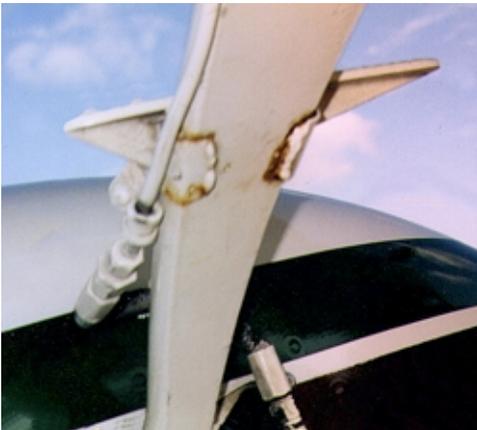
**Cessna; Model 172G; Skyhawk; Landing Gear Leg Failure; ATA 3213**

During the investigation, the technician found that the gear leg step was welded to the strut. It was apparent that the weld penetration points set up stress and caused gear leg failure. (Refer to the following illustration.) The left gear leg step was also welded and failure was imminent. The manufacturer suggests bonding the gear leg steps instead of welding them.

Part total time-5,218 hours.

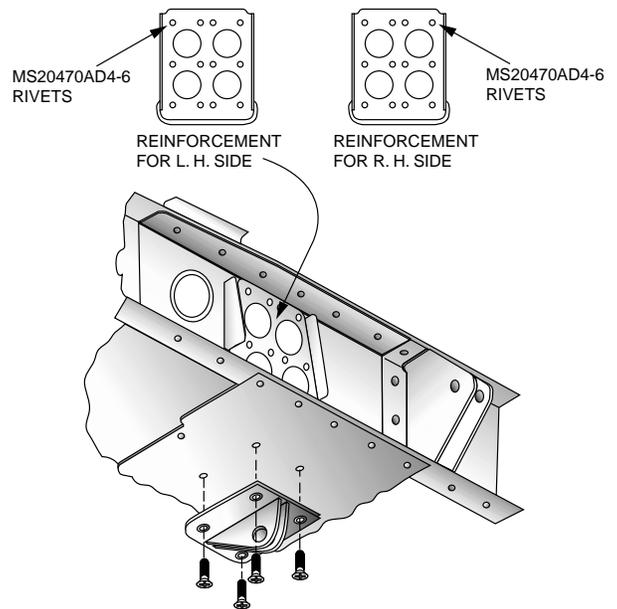
**Cessna; Model T210L; Centurion; Cracked Horizontal Stabilizer Fitting; ATA 5510**

During a scheduled inspection, the technician discovered a cracked horizontal stabilizer reinforcement (P/N 1232624-1).

The technician removed the horizontal stabilizer and discovered that both of the forward mount fittings (P/N 0732601) were loose. One of the two top rivets was sheared, and the other rivet was loose on both sides. (Refer to the following illustration.) The sheared rivet still had the machine head and the upset head in place. The submitter stated this problem could be precluded by complying with Cessna, Service Information Letter (SE) 84-17, Revision 1.

Part total time-3,781 hours.

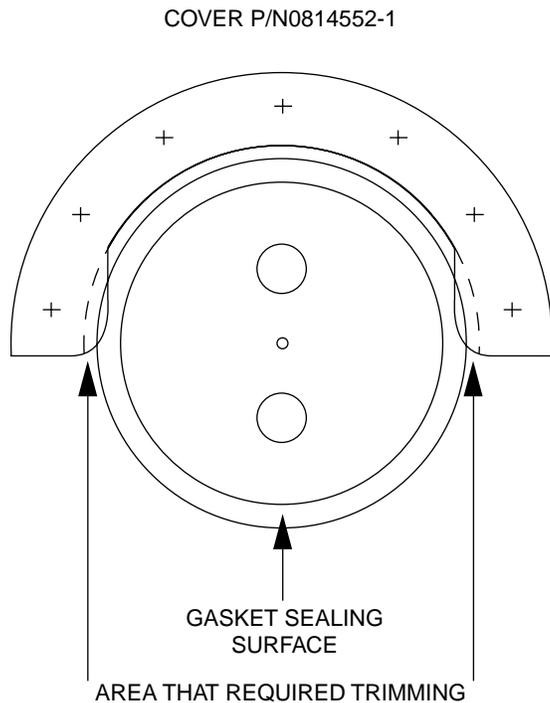
**Cessna; Model 310R; Defective Instrument Air Filter Shroud; ATA 2120**

During scheduled instrument air filter replacement, the technician discovered a defect with the filter shroud.

gasket to seal properly. (Refer to the following illustration.) The submitter reported finding this condition on another like aircraft.

Aircraft total time-7,220 hours.

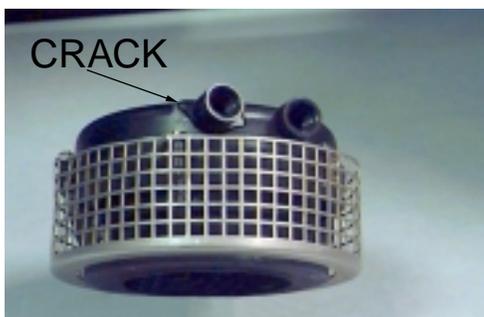
### **Lear; Model 35; Defective Pressurization System Component; ATA 2130**

The submitter suspected the safety valves installed in early serial-numbered aircraft, prior to serial number 171, may have unprotected pressurization system safety valves located in the aft baggage compartment. The location of the safety valves, and the fact that they are unprotected, can lead to abuse and damage when cargo is loaded or shifts during flight.

In this case, technicians discovered the safety valve (Lear P/N 6600207-3), installed in 1995, was cracked at the filter mounting nipple. The crack traveled around approximately 75 percent of the nipple circumference and had separated slightly. (Refer to the following illustration.)

Part total time not reported.

We urge all operators to inspect the pressurization safety valves located in the aft baggage compartment as soon as possible. Briefing flightcrews and passengers regarding the importance of securing baggage and cargo may prevent damage to the safety valve.

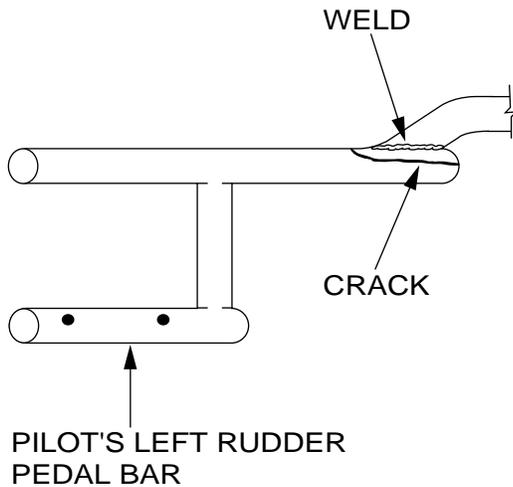
An inspection by a maintenance technician revealed a broken left rudder pedal bar (P/N 63420-05). (Refer to the following illustration.) The rudder bar broke adjacent to a welded joint on the pilot's side of the aircraft. It appeared that a crack developed at

the weld site and progressed to the point of failure. This area warrants close attention during scheduled inspections.

Part total time-4,221 hours.

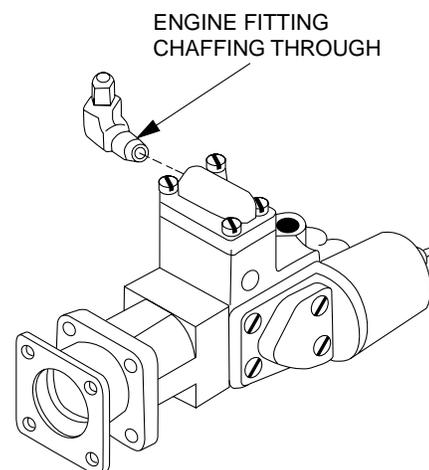
**Piper; Model PA 34-200T; Seneca II; Engine Compartment Fuel Leak; ATA 7320**

Mr. Karman Johnson, an FAA Aviation Safety Inspector (Airworthiness), discovered the following defect during an inspection. This aircraft was used in accordance with Title 14 of the Code of Federal Regulations (14 CFR) part 135 for passenger-carrying operations.

While conducting an inspection, the Principal Maintenance Inspector (PMI) discovered a fuel leak in the left engine cowling. Further investigation revealed the fuel leak came from a fuel injection pump brass return fitting. (Refer to the following illustration.) There are four different fittings used at this location. Some fittings are made of brass and some of steel. The engine nose cowling chafed hard against the injection pump return elbow fitting, and the chafing action penetrated the fitting wall thickness. This finding prompted an inspection of the right engine injection pump fittings and the PMI discovered chafing against the nose cowling. The PMI found that the chafing on the right engine was not as severe and had not penetrated the fitting wall thickness; however, a dangerous situation remained.

The submitter urges all operators of like aircraft to inspect for this condition at the earliest opportunity!

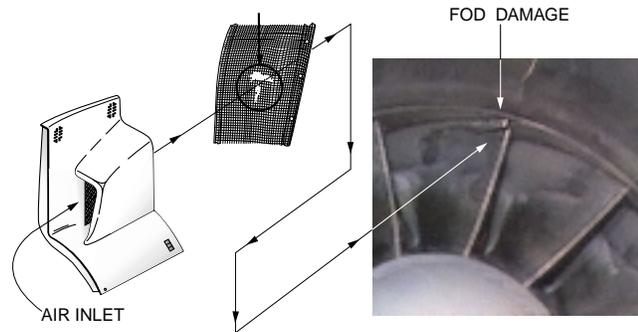
screen's operating environment and conditions, the submitter stated the screens presently used are not structurally reliable.

Part total time-142 hours.

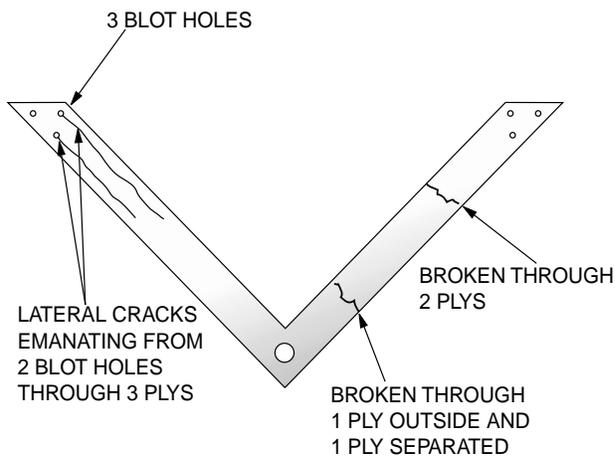
**Fly Baby; Landing Gear Damage; ATA 3211**

Part total time not reported.

also suggested that operators thoroughly inspect the landing gear "V-shaped" strut during preflight inspections.
