U.S. Department
of Transportation
**Federal Aviation
Administration**

Aviation Maintenance Alerts

**ALERT NO. 263
JUNE 2000**

**Improve Reliability-
Interchange Service
Experience**

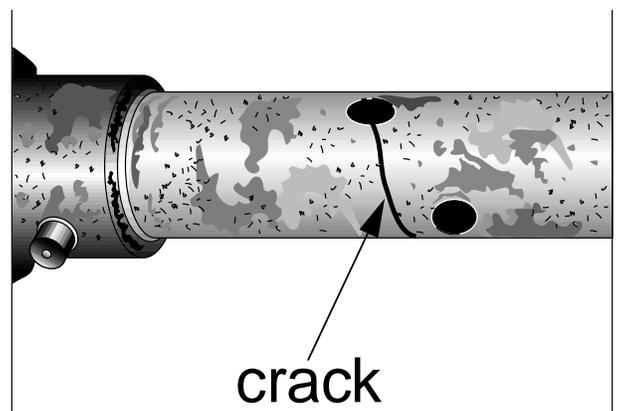
Beech; Model 99; Airliner; Defective Elevator Control System; ATA 2730

During a scheduled inspection, the technician discovered a defect in the elevator control system.

The left elevator control torque tube (P/N 115-610010-325) displayed a severe crack. The crack progressed to the point of imminent failure. (Refer to the following illustration.) The FAA, Service Difficulty Reporting (SDR) program data base contains 18 additional reports concerning various failures on this particular part. We caution all to exercise close attention to the condition of the elevator torque tube assembly during inspections and maintenance.

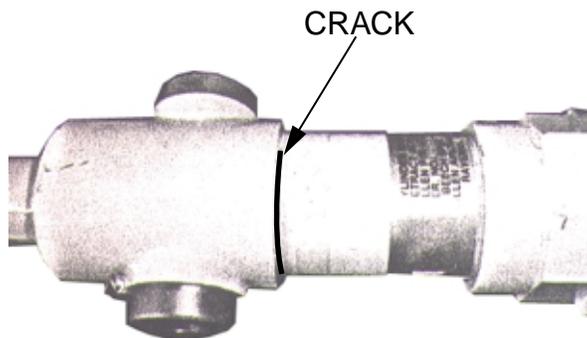
Beech; Model C99; Airliner; Defective Main Landing Gear Actuator; ATA 3233

During a postflight inspection, the technician discovered hydraulic fluid in the left main landing gear wheel well.

The technician placed the aircraft on jacks and conducted a landing gear operational test which disclosed a leak in the gear actuating cylinder (P/N 99-388008-1). After removing the actuator, he discovered the fluid leak originated from a 2-inch long crack in the cylinder housing. (Refer to the following illustration.) Given the relatively short time since the overhaul facility released this part, the technician questioned the overhaul facility's quality-control function.

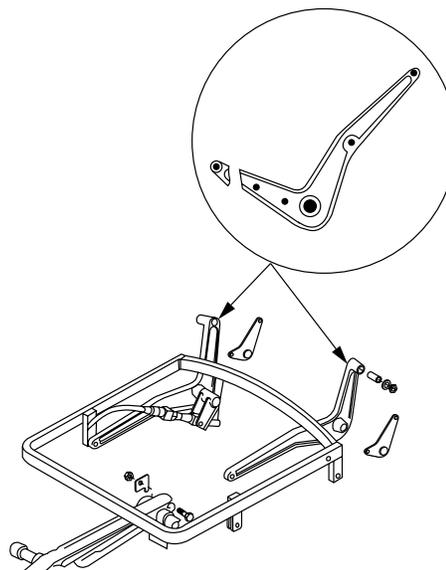
Cessna; Model 414A; Chancellor; Pilot Seat Failure; ATA 2510

A maintenance technician and the pilot investigated the cause of this incident. They found the outboard seat pivot arm (P/N 0812735-8) broken. (Refer to the following illustration.) It appeared the pivot arm casting failed due to a porosity flaw at the point of failure. The technician stated discoloration distinguished the porosity inside the casting which traveled to the surface of the casting.

A failure such as this, occurring during flight, may have fatal consequences. Therefore, it is critically important that all maintenance personnel, owners, and operators be aware of the circumstances and details of this report and take appropriate action to prevent in-flight failures. This report along with supporting data has been sent to the responsible FAA office for appropriate action.

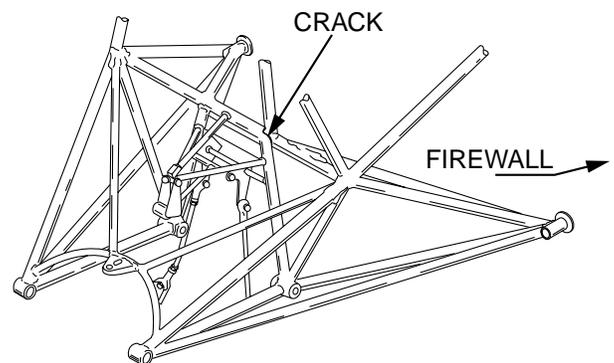
Piper; Model PA 28R-180; Arrow; Defective Engine Mount; ATA 7120

Further investigation revealed a crack in the left section of the lower cross-tube. The crack extended almost all the way around the tube circumference and was very close to complete separation. (Refer to the following illustration.) The submitter found a similar defect on another like aircraft during a 100-hour inspection. All maintenance personnel should be aware of the possible existence of this defect.

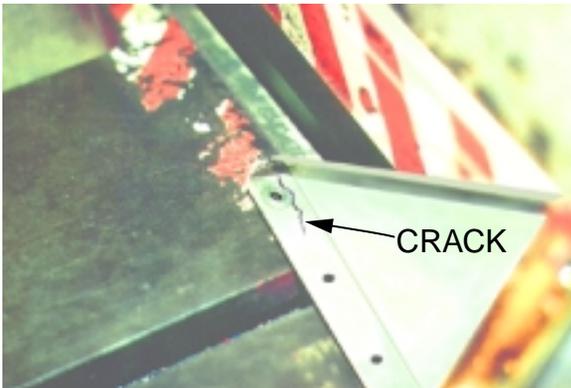
Piper; Model PA 28R-200; Arrow; Aileron Bracket Crack; ATA 2710

While conducting other maintenance, the technician discovered a crack in the left aileron bellcrank lower aileron support bracket (P/N 67550-01).

Approximately 1 year prior, the submitter found the same defect on the right aileron control system. The crack allowed the support bracket to flex enough to produce several inches of play at the aileron surface and could create a serious hazard to flight safety. (Refer to the following illustration.) In each case, a technician replaced the support bracket. The submitter speculated this type defect is a function of increasing operating time.

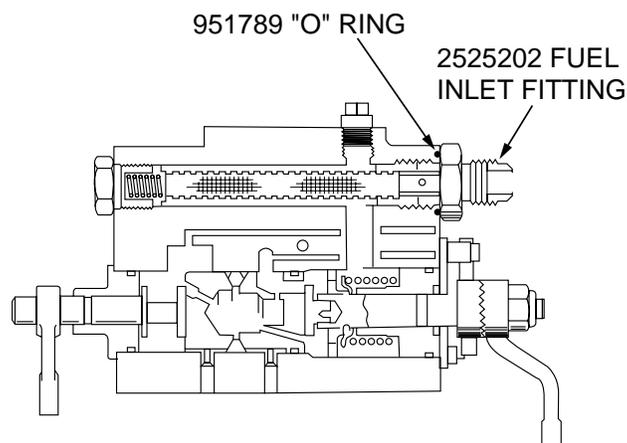
Piper; Model PA 34-220T; Seneca III; Fuel Servo Missing Seal; ATA 7322

After replacing the fuel servo (P/N 2576540-4-F) on the left engine, the technician conducted a pressure test. With pressure on the system, fuel leaked from the inlet port fitting.

The technician removed the inlet fitting and found the "O-ring" seal (P/N 951789) was missing. (Refer to the following illustration.) The fuel servo came (new) from the manufacturer with all of the fitting installed and torqued. It seems logical to assume that new aircraft parts received with fittings, hardware, and other attachments installed are ready for installation. However, as this instance illustrates, that assumption may not always be correct. Had the technician not

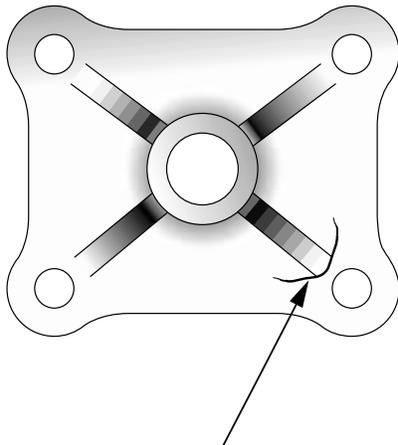
TYPICAL CRACK AREA

Piper; Model PA 42-1000; Cheyenne; Main Landing Gear Fitting Crack; ATA 3211

During a scheduled inspection, the technician found the aft main landing gear side brace trunnion fitting cracked.

The submitter included four occurrences of this defect, on the same type aircraft. All of the cracks appeared in or adjacent to the casting web of the fitting and were in the area of the inboard lower bolt hole. (Refer to the following illustration.) These cracks were not readily visible and were manifest by a small discontinuity in the paint covering. The side brace rear trunnion fitting (P/N 40294-06) is used on other Cheyenne-series aircraft, and it

is recommended that this area be closely checked during scheduled inspections.

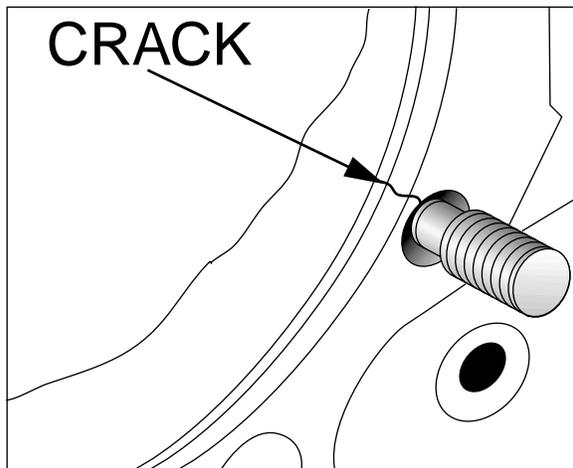
The technician found the same defect on the number four cylinder on the right engine. (Refer to the following illustration.) On the right engine, the crack relieved tension on the stud and allowed it to turn into the case and contact the connecting rod throw. The resulting force caused massive multiple fractures of the engine case.
