ADVISORY CIRCULAR 43-16A

AVIATION MAINTENANCE ALERTS

**ALERT
NUMBER
269**

**DECEMBER
2000**

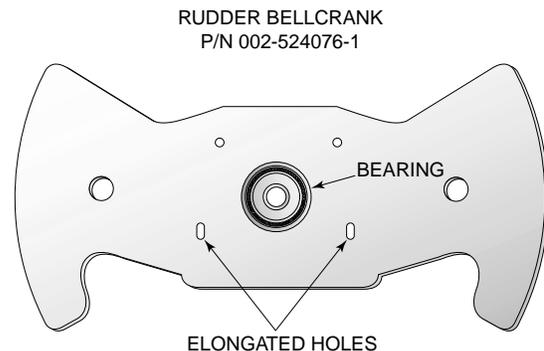
During a scheduled inspection, the inspector noticed a loose rudder attachment.

After disassembly, the technician discovered two of the four fastener holes in the bellcrank were elongated. (Refer to the following illustration.) These four holes attach the rudder mast (P/N 96-630000-333) to the bellcrank (P/N 002-524076-1). These four bolts appeared to be tight, and the technician could offer no reason for the elongation wear in the two holes.

The submitter suggested closely checking this area during scheduled inspections. Even though the "free play" in this case was slight and could very easily be overlooked, it could have caused rudder flutter.

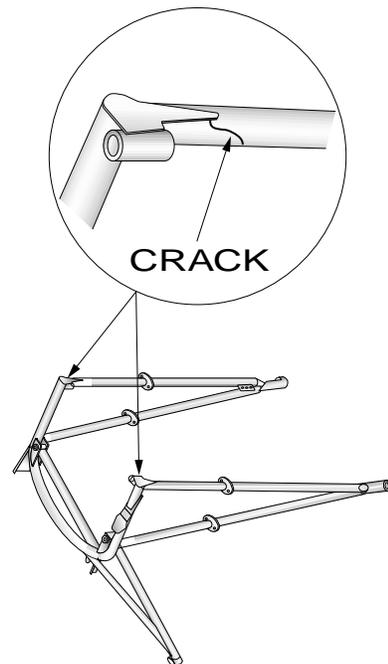
During a scheduled inspection, the technician discovered a crack in a right engine mount point.

The crack was located adjacent to a gusset weld at the upper outboard engine truss mount (P/N 129-910032-79). (Refer to the following illustration.) This defect is typical of those depicted in Airworthiness Directive (AD) 95-02-18 and Beech Service Bulletin (SB) 2255. AD 95-02-18 may also affect truss part numbers: 114-910025-1, 118-910025-1, 118-910025-37, and 118-910025-121. Refer to AD 95-02-18 and SB 2255 for specific applicability and data.

In accordance with AD 95-02-18, the submitter removed and replaced the truss assembly with an updated part (P/N 129-910047-17) which terminated the recurring inspection requirements. The new truss requires magnetic particle inspection at 8,000 operating hour intervals.

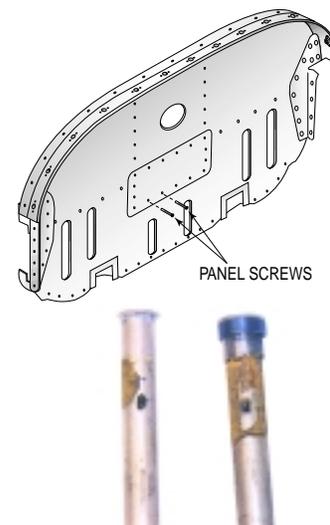
While installing a fuel line cross-feed kit (Cessna P/N SK340-31-6), the technician discovered two fuel lines severely chafing.

In the process of removing the old fuel lines (P/N's 5600106-31 and -3), the technician found the wall thickness of these lines was almost penetrated by chafing action. (Refer to the following illustration.) The lines were originally covered with chafe protection, and the damage was not evident until the chafe protection was removed. The screws used to install an inspection panel caused the chafing. The damage location provides very little clearance for the panel screws, and it is very important to choose the proper screw length.

The submitter suggested verifying the fuel tubing/panel screw has clearance and adequate chafe protection is evident.

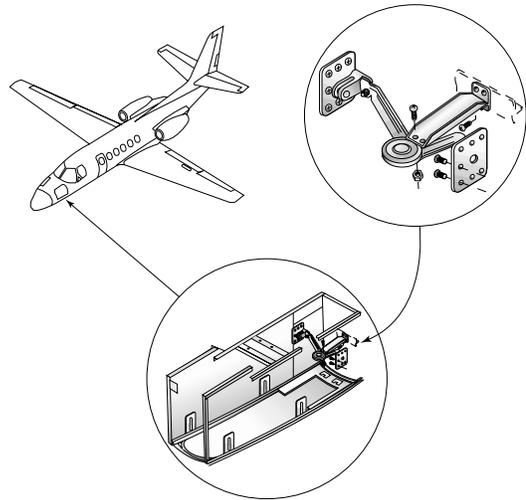
While conducting an inspection, the technician found the nose landing gear trunnion loose.

After investigating further, he discovered the screws (P/N NAS517-3-X) used to secure the left and right nose gear trunnion supports (P/N's 6613056-3 and -4) loose. (Refer to the following illustration.) He stated there is no required inspection time for this assembly; however, he suggested an inspection each 150 hours of operation. The location of these fasteners makes inspection and installation very difficult even with the aircraft on jacks. However, the time and effort spent is well worthwhile considering the damage that loose or dislodged fasteners may cause.

The submitter found this defect on several other like aircraft with comparable operating time.

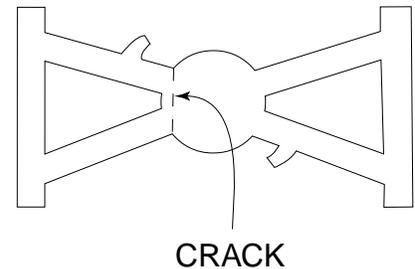
While complying with the requirements of an annual inspection, the technician discovered a crack in the nose gear steering horn.

The nose gear steering horn assembly (P/N 35192-00) was cracked where it attaches to the nose gear strut. However, the crack did not penetrate the horn thickness. (Refer to the following illustration.)

The submitter suspects this crack occurred when excessive rudder pedal pressure was applied with the aircraft on the ground and not moving. Also, exceeding the turning limit during the aircraft's ground movement or a nosewheel landing may have caused this defect.

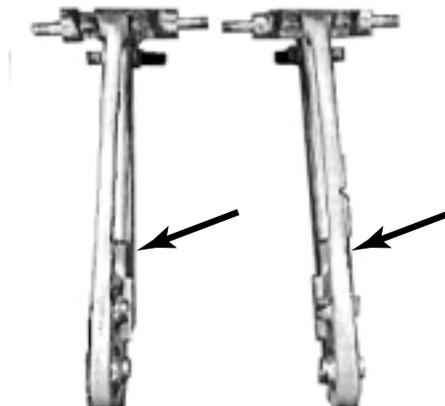
The flight control servos (P/N 206-076-062-101) were being removed due to time change.

The technician noticed both of the servo extension (P/N C42642-69) assemblies bent to one side approximately .25 inch. The servo extension operating pressure is 1,000 PSI. (Refer to the following illustration.) This servo is the same design as the ones used in Bell Models 206L-1 and L-3, except operating pressure is 600 PSI. Other than the higher operating pressure, the submitter did not offer a cause for this defect.

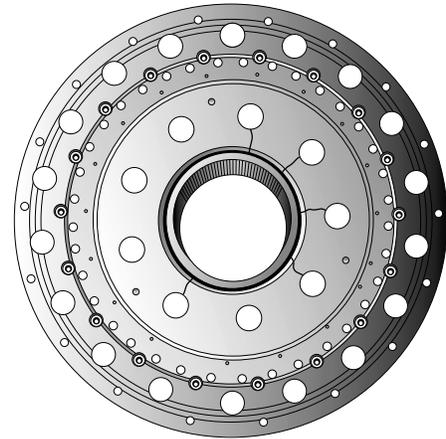
While disassembling the main rotor gearbox (P/N 6435-20400-063) for overhaul, the technician found five cracks visually.

The cracks radiated from five of the nine lightening holes in the lower plate of the second-stage planetary plate assembly (P/N 6435-20231-014). After finding this problem, the technician conducted a magnetic-particle inspection and found three additional cracks. (Refer to the following illustration.) The longest crack was approximately 3.5 inches long and extended into the center hub. Seven of the eight cracks originated on the inboard side of the lightening holes and extended at a 45-degree angle toward the center hub radius. This part was in imminent danger of catastrophic failure.
