U.S. Department
of Transportation
**Federal Aviation
Administration**

ADVISORY CIRCULAR 43-16A

AVIATION MAINTENANCE ALERTS

**ALERT
NUMBER
271**

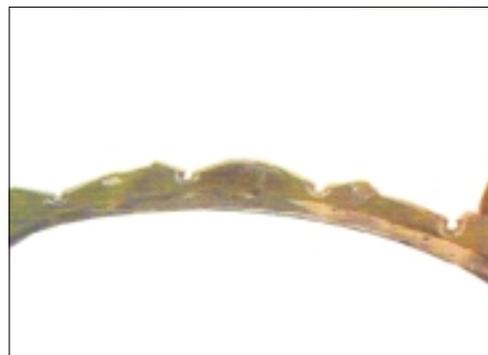
While replacing the pressurization seal on a cabin window emergency exit, the technician removed the upholstery and discovered the window was defective.

The technician found the outer cabin window (P/N 5111605-2) was broken between the fastener holes that secure it to the aircraft structure. (Refer to the following illustration.) The broken pieces of the window were held in place by a liberal amount of "RTV" sealant. He stated improper installation procedures and a lack of attention to detail caused this defect. Aircraft windows will not stand preload stress necessary to conform to the asymmetrical contours of the aircraft structure. Even slight variances may cause enough stress to cause cracking defects immediately or over time.

The submitter installed a new window and a metal retainer ring as required in Cessna Service Bulletin MEB 87-4.

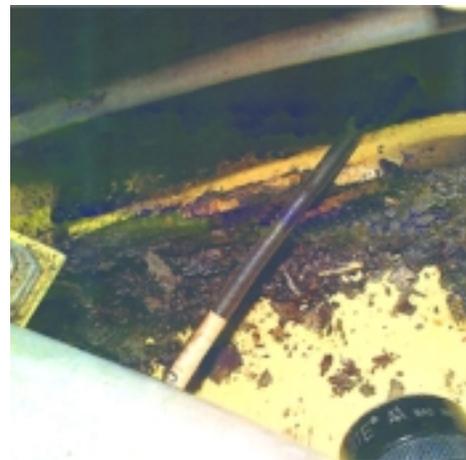
While investigating a report of fuel fumes in the aircraft cabin, the technician discovered an area of severe structural corrosion.

The corrosion was located under the cabin floor on a stringer that is just below the aileron bellcrank. The severity of this damage seriously compromised the structural integrity of the airframe and could have caused interference or failure of the aileron system. (Refer to the following illustration.)

The submitter reported finding a similar defect on another like aircraft. The damaged area is not easily seen; however, he suggested conducting a diligent and thorough inspection at every opportunity.

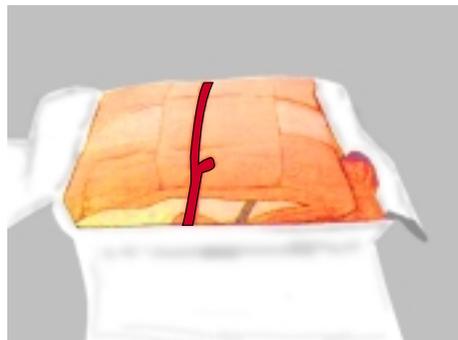
During a scheduled inspection, the technician discovered an emergency evacuation slide was not in a condition to operate properly.

The slide (BFG, P/N 5WD230600-203) was installed in the aircraft with a 2-inch wide, 8-foot long red webbing strap tied around the folded inflatable slide. The entire unit was packed inside the outer slide pack which is installed on the aircraft door. (Refer to the following illustration.) The webbing strap would prevent deployment of the slide and create a detriment during an emergency.

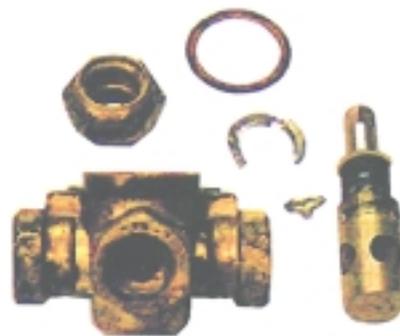
The aircraft owner reported the fuel selector valve was very stiff to operate.

A maintenance technician found the selector valve (P/N 491-497) operation was extremely stiff and had no detectable detents. In addition, while exercising the selector valve, he found that it would occasionally seize at random positions. When he removed and disassembled the selector valve, he discovered the internal detent ring was deformed and broken. (Refer to the following illustration.) After he replaced the selector valve, it functioned properly, and he approved the aircraft for return to service.

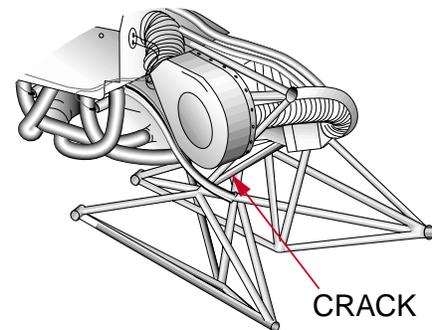
During an annual inspection, the technician found an area on the engine mount (P/N 67119-57) which he suspected was cracked.

The technician stripped the paint from the area and confirmed there was a crack located on the lower left side of the center cross tube adjacent to a weld. (Refer to the following illustration.)

The submitter stated that any engine-mount anomaly should be thoroughly investigated.

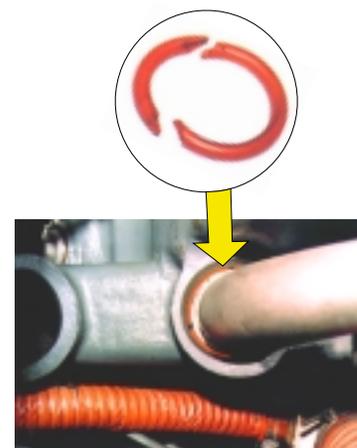
The owner brought his aircraft to a maintenance shop and reported the engine performance was poor and deteriorating.

A technician found the engine would hardly run at idle, manifold pressure was abnormally high, and afterfired during throttle reductions. He also noted high exhaust gas temperature (EGT) on the number 3 cylinder. He shut down the engine, opened the cowling, and discovered the number 1 and number 3 cylinder intake seals were partially ingested. (Refer to the following illustration.) Fortunately, pieces of the seal were not drawn into the cylinders.

The submitter observed, “There is no reason why or how these seals could be ingested if they were installed properly!”

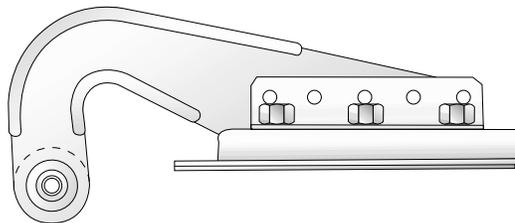
After returning from a flight, the pilot reported a landing gear door was broken.

A technician inspected the aircraft and found the left main gear door forward hinge (P/N 47529-32) was broken and the door was bent from contacting the wheel. (Refer to the following illustration.) The submitter recommended stripping the paint from these hinges and inspecting them prior to installation. He stated particular attention should be given to the large inner hinge radius.

Airworthiness Directive (AD) 80-26-05 deals with this subject, and this aircraft was in compliance with the AD. In accordance with the AD, the original hinges were replaced with a new design (P/N 474529-32).

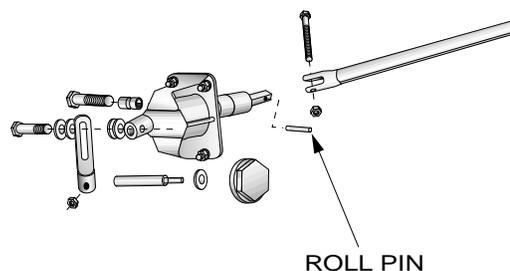
The pilot returned from a flight and reported the rudder trim was inoperative.

A technician investigated and found one of the two roll pins (P/N 480-735), which secure the actuator screw rod-end to the trim tab push-pull tube, had migrated almost completely out of the hole, and the other roll pin was missing. (Refer to the following illustration.) The technician installed two new roll pins and safety wired them in place.

The submitter suggested conducting an inspection of this area to ensure these roll pins are safety wired.

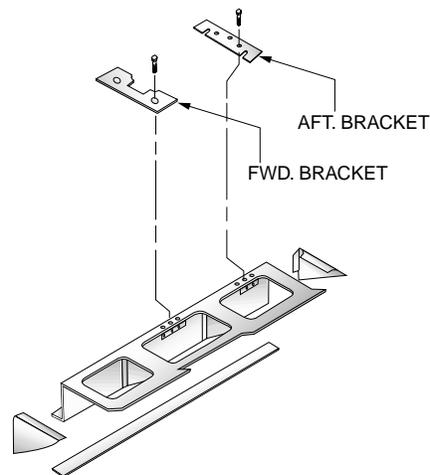
While conducting a 100-hour inspection, the technician found both battery holddown brackets were severely worn.

The battery holddown brackets (P/N's G10110, fwd and G10115, aft) were worn at the slots that hold the battery in place. (Refer to the following illustration.) These parts were installed as part of a Supplemental Type Certificate (STC) assembly which locates the battery in the tail boom. The technician maintains three like helicopters, and they all displayed the same defect. When he attempted to install replacement brackets, he discovered the holes did not match the attachment points even though all three aircraft were the same. He contacted the manufacturer and learned that at least two drawing changes were made. At the time of this report, he is working with the manufacturer to resolve this problem.
