# ADVISORY CIRCULAR 43-16A

# AVIATION MAINTENANCE ALERTS

**ALERT  
NUMBER  
284**

**MARCH  
2002**

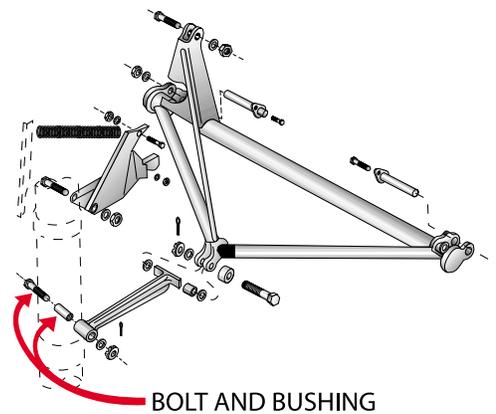
The technician discovered the right main landing gear leg assembly (P/N 35-815129) was defective. A bolt (P/N AN5-22/M) and bushing (P/N 35-815124) attach the leg assembly to the main gear. Also, there is a lubrication fitting (grease zerk) installed at this attachment point. (Refer to the illustration.) The bolt and bushing were partially frozen and binding even though lubrication (grease) was evident at bushing sides. The binding action compromised the full extension of the downlock and caused a false "down-and-locked" indication in the cockpit.

The submitter speculated that during landing, a crosswind caused enough side load on the gear to disengage the downlock mechanism. He suggested the bolt and bushing for both main gears be removed, cleaned, inspected for condition, lubricated, and reinstalled every 300 hours of operating time.

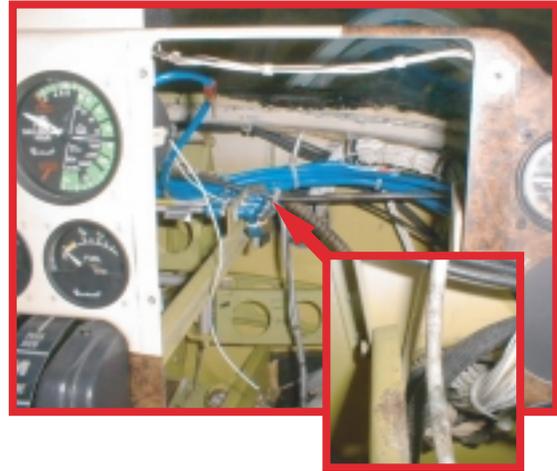
The corrosion penetrated the fuel pressure line (P/N 96-324128-121), located in the cockpit behind the instrument panel, to the point of imminent failure. The technician believes the corrosion was caused by moisture coming from the windshield defroster hose (Aeroduct) routed just above the fuel pressure line. The fuel line damage area was approximately 6 inches long, and the metal was brittle. (Refer to the illustration.)

A fuel leak, especially in the cockpit, creates a very dangerous compromise to both flight and ground safety. Regardless of the make and model of aircraft serviced, technicians should be constantly alert for this type of potentially fatal defect.

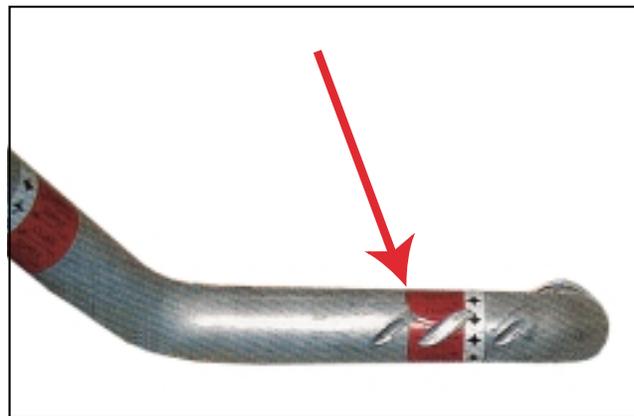
The right engine main fuel supply tube (P/N 6716000-26) was chafed deeply in two locations. The right elevator cable was chafing and had worn grooves in the fuel tube just forward of the right battery. The chafing action had almost penetrated the fuel tube. (Refer to the illustration.) He discovered the line had been installed “backwards” and caused interference with the elevator cable. After he installed a new tube correctly, there was ample clearance from the elevator cable.

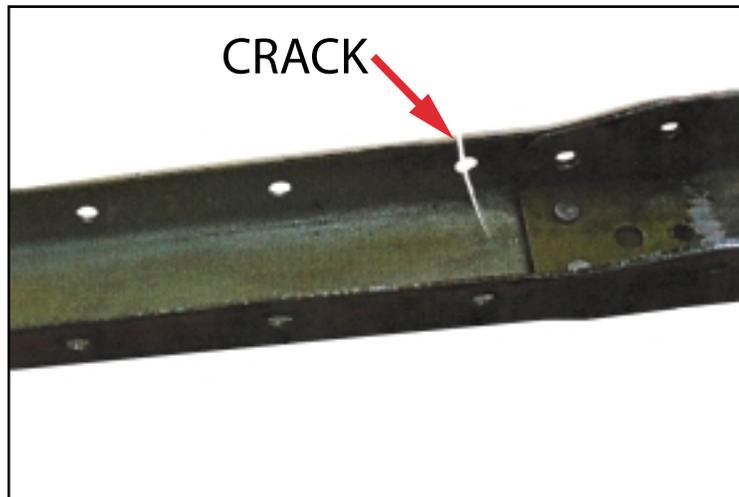
The defect was located in an area that was not visible, and the technician was using a borescope. The spar (P/N 40075-16) was cracked from the edge, through a fastener hole and the radius, and extended through approximately 75 percent of the spar. (Refer to the illustration.) The crack was located at the outboard end of the spar.

AD 99-12-05 requires compliance within 1,000 hours of the effective date of the AD. This defect was found at 730 hours from the AD's effective date. The submitter suggested that sooner compliance might be warranted.

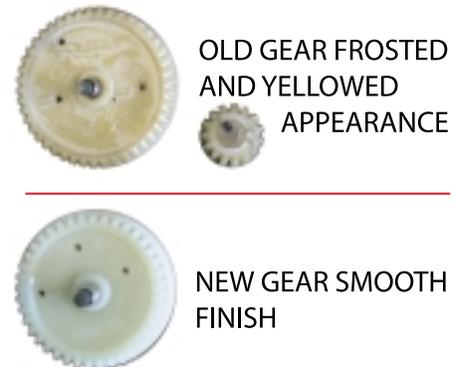
The technician disassembled the left magneto and noticed the nylon gears had a “frosted” appearance. The distributor and cam gears were deteriorated and crazed. (Refer to the illustration.) An electronic tachometer pickup (Piper P/N598-881), incorporating a vent filter, was installed in place of the normal vent. He removed the tachometer pickup and discovered the air would not pass through the vent. Investigating further, he discovered the air passage on the magneto side was not properly drilled through to the filter chamber. He returned the unit to the manufacturer for evaluation. He believes the nonfunctioning vent allowed the magneto to overheat and caused the gears to deteriorate.

The submitter recommended reducing the inspection interval for the magnetos from 500-hours to 250-hours. The inspection should include removing the tachometer pickup and verifying that air passes through the filter chamber. Also, he recommended the manufacturer increase the air passage size to allow better venting.

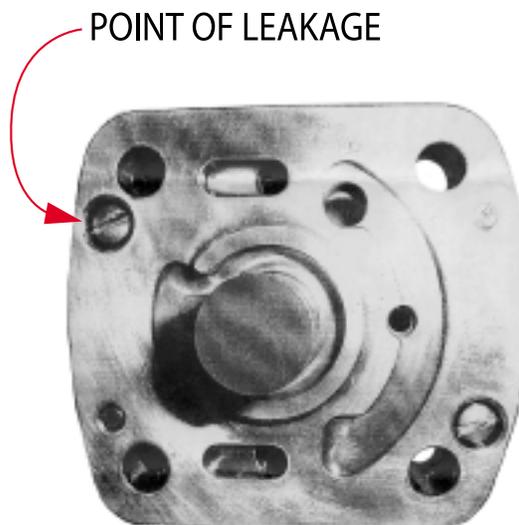
The new governor installation instructions refer to a gasket (P/N B-20024). However, the gasket that comes with the governors is gasket (P/N MS914401). The submitter recommended the manufacturer ensure the proper gasket is supplied with the new governors. Oil leaking from the propeller governor could result in oil starvation and failure and an in-flight fire.

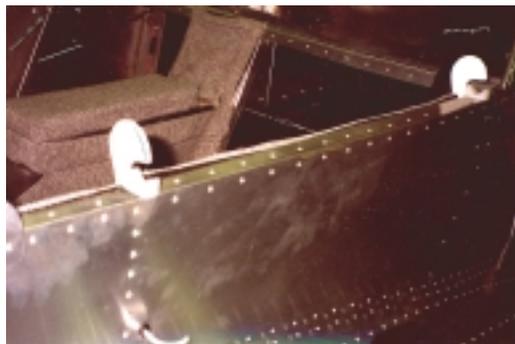
This aircraft uses a side-hinge canopy. After examining the canopy system, the owner determined the locking-hook device (P/N 6E2-1) failed to secure the canopy. (Refer to the illustration.) He believes the canopy-retention system has a design problem and stated his knowledge of several other similar failures. Other occurrences of this failure were not found in the FAA Service Difficulty Program data base; therefore, he assumed the other failures were not reported.

The aircraft kit manufacturer has designed and issued a forward-hinged canopy as a replacement.
