U.S. Department
of Transportation
**Federal Aviation
Administration**

ADVISORY CIRCULAR

AVIATION MAINTENANCE ALERTS

**ALERT
NUMBER
311**

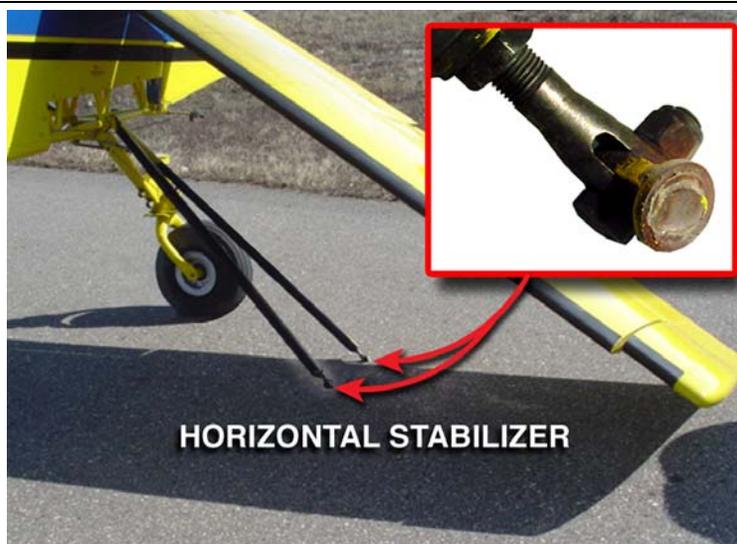
Air Tractor, Inc.; Model AT-602; Horizontal Stabilizer-to-Stabilizer Strut Eyebolt Failure; ATA 5551

An Air Tractor AT-602 was being ferried to Canada from the southern part of the United States. During the flight, the horizontal stabilizer failed and resulted in a forced landing.

A technician discovered the eyebolt that attaches the horizontal stabilizer spar to the stabilizer struts had failed. (Refer to the illustration.)

The FAA strongly recommends the registered owner and operator comply with Special Airworthiness Information Bulletin (SAIB) CE-04-23, dated December 2, 2003. The SAIB can be retrieved at www.faa.gov then search for "SAIBs."

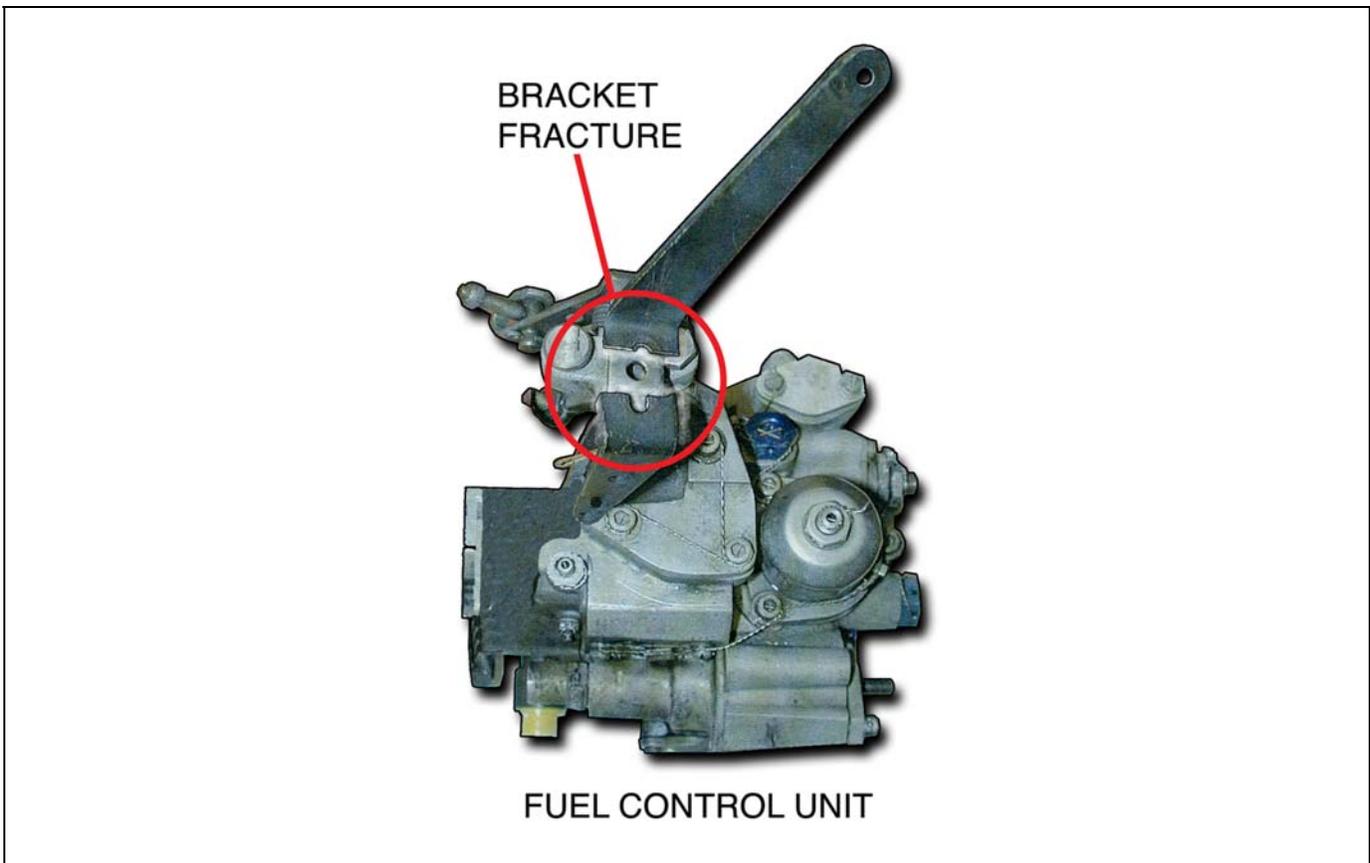
Piper; Model PA-31T1; Cheyenne I/IA; Fractured Start/Stop Control Lever Bracket; ATA 7600

During a ground performance run, the technician could not shutdown the left engine. He discovered the left engine start/stop control lever bracket (P/N 49664-02) had fractured at the fuel control unit (FCU) mounting hole. (Refer to the illustration.)

The submitter reported one additional failure, which was also discovered at his repair station.
