U.S. Department
of Transportation
**Federal Aviation
Administration**

ADVISORY CIRCULAR

43-16A

AVIATION MAINTENANCE ALERTS

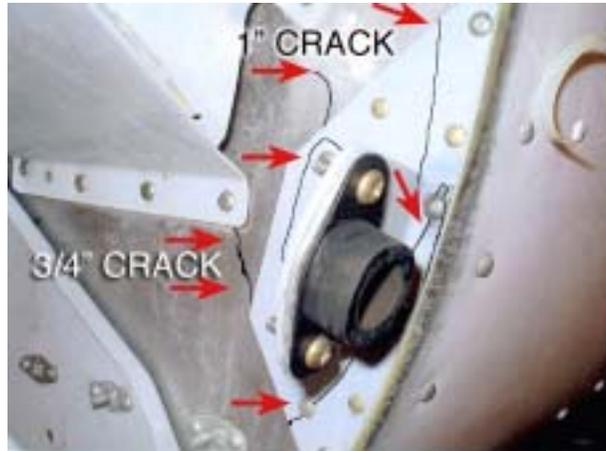
Cessna; Model 172R; Skyhawk; Cracks in Lower Firewall; ATA 5312

During an inspection, the technician found numerous cracks in the lower firewall (P/N 0553031-5) left side zone 124. The cracks radiated from the lower battery mount and cowling mount brackets. (Refer illustration.)

The submitter stated that he was aware of three additional like aircraft where the firewalls developed cracks in the same area.

A search of the FAA Service Difficulty Reporting Program data base contains 20 reports on Cessna 172R with firewall cracks. Most of the reports were generated while complying with Service Bulletin 98-53-02.

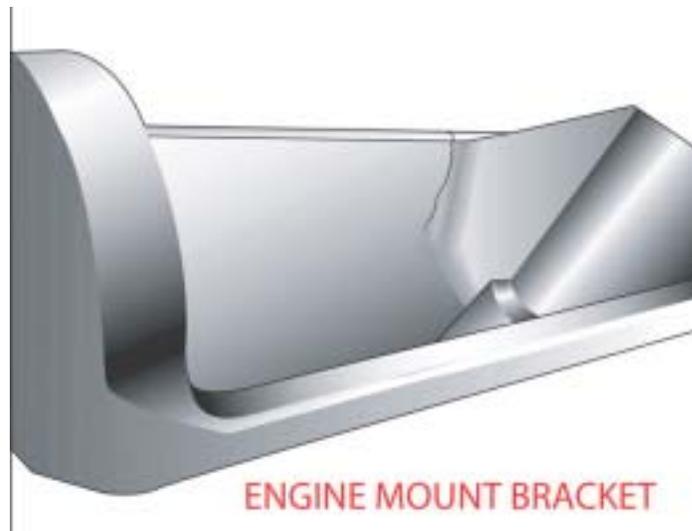
Cessna; Model T-303; Crusader; Cracked Engine Mount; ATA 7120

During an annual inspection, the technician discovered the inboard lower engine mount leg (P/N 643042) was cracked on the left engine.

The aircraft total time was 4,392 hours, and the engine total time was 685 hours since factory rebuilt. The crack was about 1-1/8 inches long and located at the lower edge 3 inches from the engine attach point.

The submitter also stated that it had a small porosity void 3/8 inch from the edge of the mount leg and in line with the crack. (Refer to the illustration.)

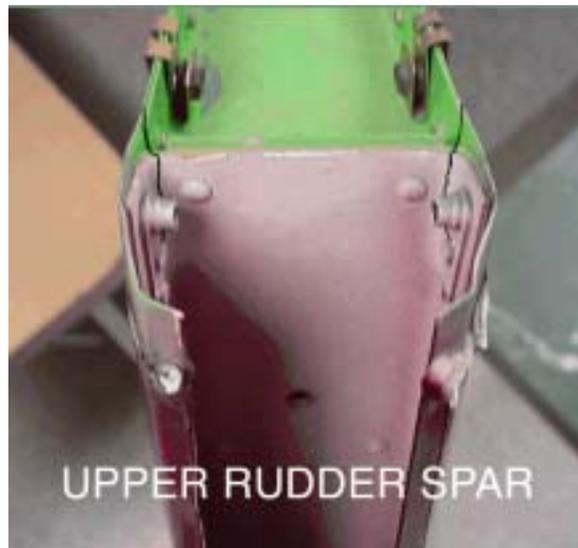
Piper; Model PA-28R-201; Arrow IV; Cracked Rudder Spar; ATA 5541

While inspecting the upper rudder spar (P/N 63543-00) and doublers (P/N 65341-00), the technician found cracks on both sides of the bend radius.

Both cracks were about $\frac{3}{4}$ to 1 inch in length from the top of the rudder to the nut plate. (Refer to the illustration.)

The operator inspected 13 additional PA-28R-201 aircraft in his fleet, and discovered two of the aircraft had spar cracks and four of the aircraft had cracked doublers.

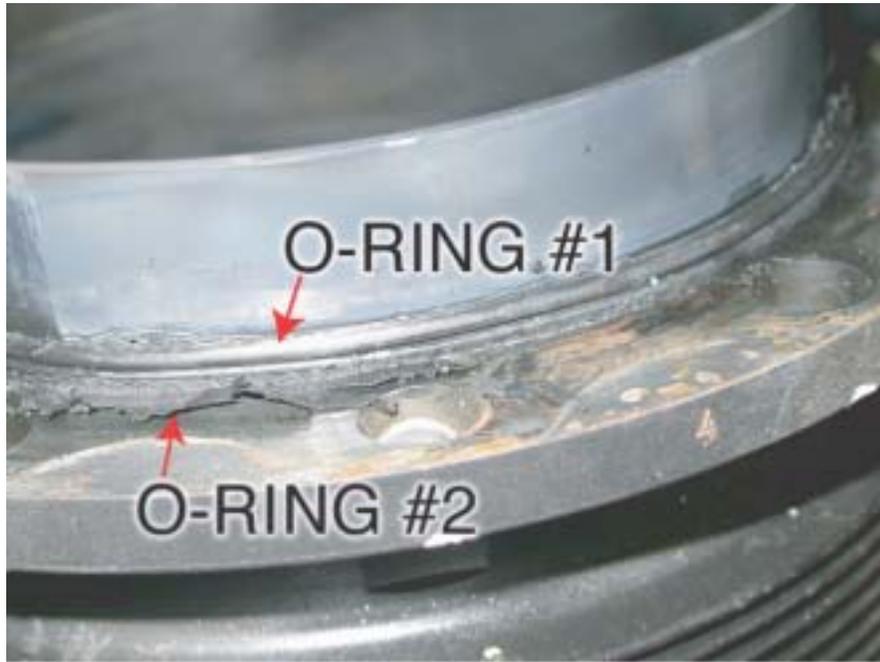
DUAL O-RING INSTALLED ON ENGINE CYLINDER BASE

During an annual inspection, it was discovered that one of the cylinder hold down studs had a missing nut. The nut was found lying in the cylinder baffling area. A torque check of the remaining nuts showed that several had become loose. The cylinder was removed to investigate. Upon removal, the mechanic found that the suspect cylinder had two cylinder base seals installed. The o-rings were deformed and compressed. Due to the two o-rings installed the original torque values had changed allowing one nut to come completely off and several remaining nuts to loosen. If not found it is possible that the cylinder could have eventually come loose from the crankcase causing severe engine damage or failure. The engine had 121 hours since new. (Refer to the illustration).

Maintenance personnel should take precaution when finding cylinder hold down hardware missing or loose. This incident is probably an isolated production error but demonstrates that further investigation into a problem can lead to discovery of additional problems that may not be apparent from a visual inspection.
