U.S. Department
of Transportation
Federal Aviation
Administration

ADVISORY CIRCULAR 43-16A

AVIATION MAINTENANCE ALERTS

**ALERT
NUMBER
289**

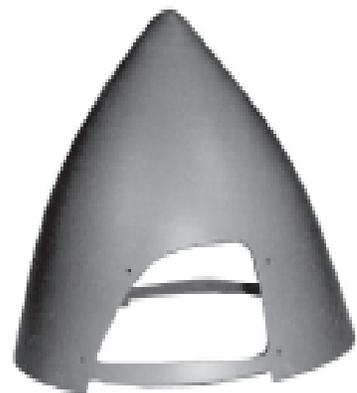
A technician ordered a new propeller spinner to replace one that was severely damaged.

The submitter suggested that the manufacturer make improvements to their quality control system to preclude delivery of defective parts.

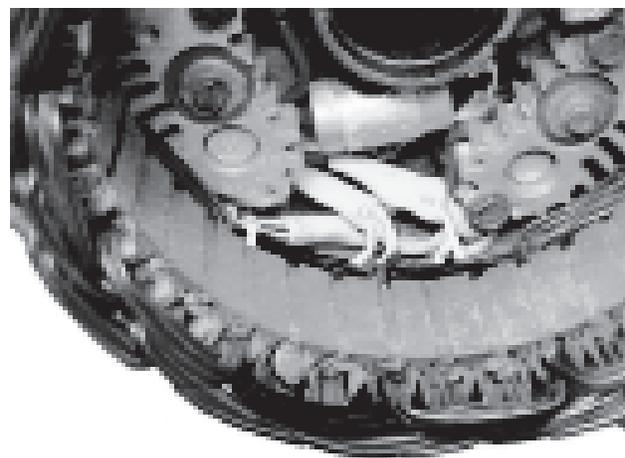
The technician disassembled the alternator (Teledyne Continental 649304), and discovered that several stator windings displayed evidence of overheating. The stator windings were severely blackened and charred. (Refer to the illustration.)

The submitter stated his facility has been performing the 500-hour inspection at 400 hours because of an increased failure rate. The 500-hour inspection is required by Teledyne Continental Motors (TCM), Service Bulletin 01-3, and Beech Service Instruction, Class 1, 0546-359R2. The alternator was “working fine” before the inspection.

The FAA Service Difficulty Program data base contains an additional eight reports of alternator failures. Of those eight reports, only six gave the operational time at failure. The reported failure times were 304, 191, 173, 143, 39, and 10 hours. One way to identify this type of damage is by conducting a “sniff” test. Any burning of the alternator interior may be detected by smell, and the human nose is an excellent instrument for that purpose.

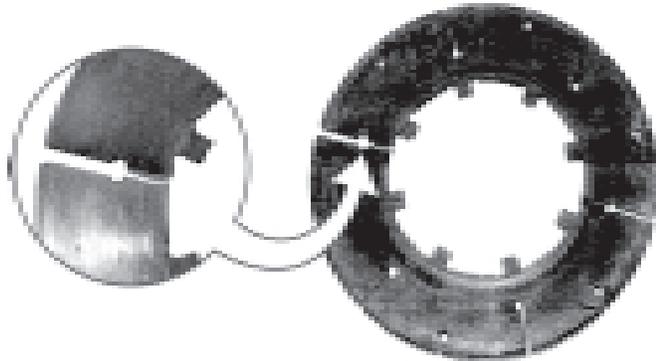
Recently, Transport Canada received a report from an operator that has experienced multiple brake failures due to broken stators. A search of the Service Difficulty Reporting (SDR) database shows four Cessna 500 Series brake failures due to broken stators.

During a Phase 5 inspection when the stators on the brake assemblies were checked at approximately 600 landings. One disk in the stack was cracked through with all the other holes cracked approximately 75%. Most of the expansion slots were found completely closed off at the outer edge. This post service bulletin unit could have hard failed in a very short period of time if not detected.

Transport Canada highly recommends that operators check these brakes at your earliest convenience to prevent possible brake lock up due to broken stator assemblies.

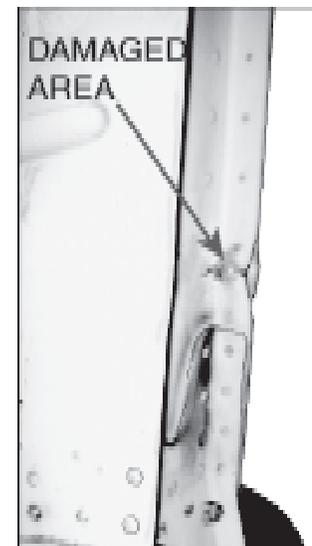
During a scheduled inspection, a technician discovered structural damage on the vertical stabilizer.

The technician removed the rudder to fully access the condition of the vertical stabilizer. The damage was located on the lower right side of the aft end of the vertical stabilizer (P/N 66975). The aft web was bent and cracked to approximately the midpoint. (Refer to the illustration.) It appeared the vertical stabilizer damage was caused by impact of a foreign object.

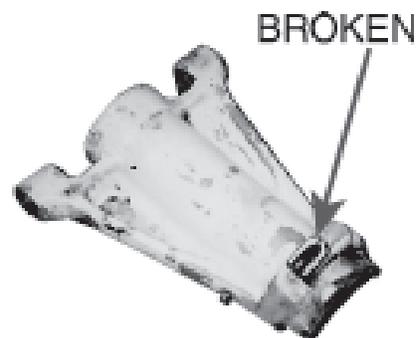
While conducting an annual inspection, the inspector discovered the nose landing gear strut housing was broken.

The nose gear strut housing (P/N 67054-03) boss was broken where the lower drag link attaches. Approximately half of the boss was missing. The remaining assembly was covered with grease, dirt, and other debris. (Refer to the illustration.) This discrepancy was only found after the technician cleaned the excessive grease from the assembly. He could not determine how long the part had been broken.

The submitter speculated the damage was caused by hard landings and/or misrigging the retraction system.

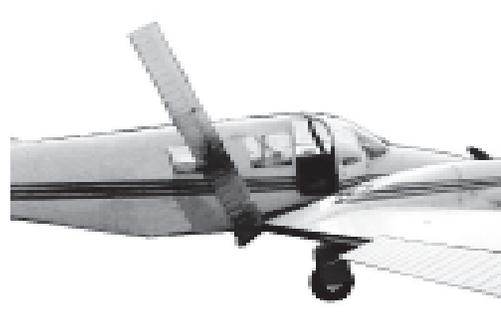
The instructor observed the right flap had separated from the two outboard hinge points and folded upward and aft to a vertical trailing position. By reducing power on the left engine, he regained aircraft control at approximately 300 feet AGL. To maintain directional control through the landing, he had to vary engine power and use approximately a 10-degree side-slip.

While inspecting the aircraft, a technician found the wing flap interior was severely corroded at the interfaces of the aluminum nose ribs (P/N 62328-00 and P/N 62328-01) and the steel flap hinge brackets (P/N 65899-00). The nose ribs were worn almost to the point of disintegration. Evidence indicated the flap had been opened for maintenance prior to this incident. Due to the corrosion on the steel hinge brackets, the two outboard hinge points failed. (Refer to the illustration.)

It is amazing that the flap did not completely separate from the aircraft. There was evidence of corrosion on the exterior of the wing flap, which should have led maintenance personnel to investigate further.

This incident was very close to a catastrophic double fatality accident. All operators are urged to check for similar defects as soon as possible.
