## ADVISORY CIRCULAR 43-16A

# AVIATION MAINTENANCE ALERTS

**ALERT  
NUMBER  
295**

**February  
2003**

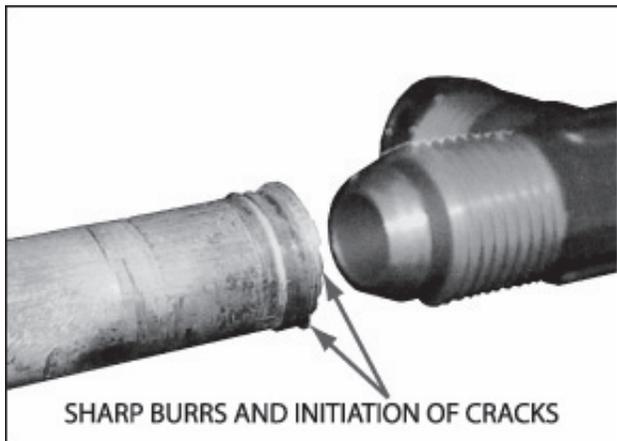
The pilot reported that fuel was leaking from the inverted fuel system header tank.

The technician performed a visual inspection of the inverted fuel system header tank fuel distribution lines and discovered six fuel leaks. He stated the fuel leaks occurred from improper flaring of the 3/8-inch aluminum lines. (Refer to the following illustration.)

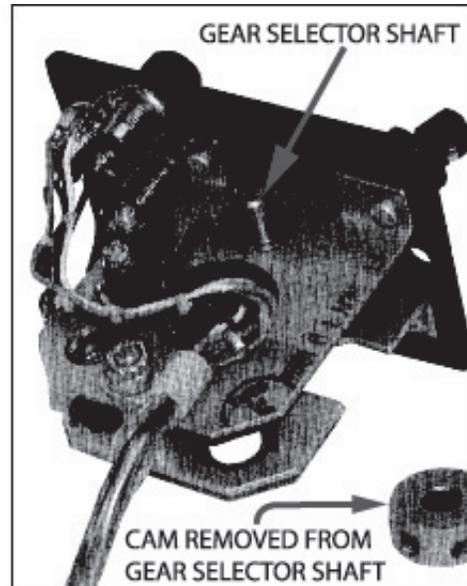
The pilot reported the landing gear warning horn was sounding in the cockpit as he taxied the aircraft. During a subsequent takeoff, the landing gear retracted as soon as the aircraft left the ground; however, the landing gear control switch was in the "down" position. He had difficulty getting the landing gear into the "down-and-locked" position.

Electrical troubleshooting established that the landing gear control switch was commanding gear retraction even though the switch was in the “down” position. The landing gear control switch (P/N 36-380050-1) was removed from panel for inspection. The technician discovered the cam that actuates the microswitch to raise and lower the landing gear was loose. The cam is held in place with two setscrews that lock the cam to the gear selector handle shaft. He stated that one setscrew was not making contact with the shaft and the other setscrew was only making light contact. (Refer to the following illustration.)

The submitter suggested the technicians ensure a more positive manner for locking the cam to gear selector switch shaft. A search of the FAA Service Difficulty Reporting (SDR) System data base revealed one additional report on this subject matter.

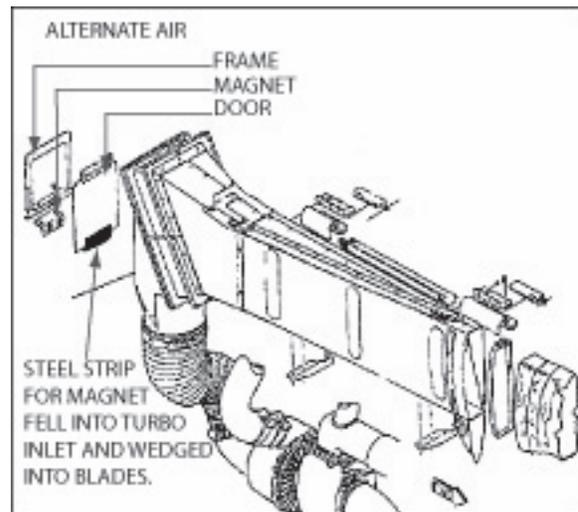
The pilot reported that during the takeoff roll, the engine turbocharger failed.

The technician determined the steel strip for the induction alternate air door magnet (P/N 1250839-21) wedged into the turbocharger inlet blades. All the leading edges of the turbocharger inlet blades were damaged. (Refer to the following illustration.)

The submitter believed that due to dissimilar metal corrosion between the steel strip and the aluminum attachment rivets, the steel strip separated and was drawn into the turbocharger inlet.

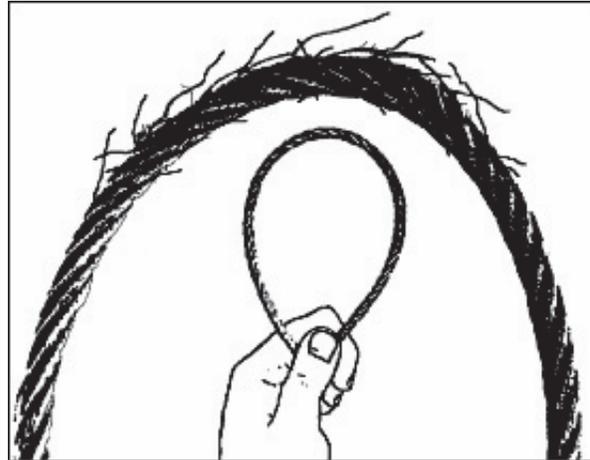
This aircraft experienced an asymmetric flap extension as the result of a failed flap cable. Excessive wear at the right hand inboard bellcrank caused this failure. The wear occurred at the tight radius of the bend and was not be noticeable until the cable was removed.

The maintenance manual requires a 100-hour inspection of the flap cable system. It is recommended that maintenance personnel treat this bellcrank and all others in this system as a “critical fatigue area” as defined in AC 43.13-1B, Acceptable Methods, Techniques, and Practices - Aircraft Inspection and Repair, chapter 7, section 8, paragraph 7-149(b). These areas require a close visual inspection, which can only be accomplished by removing the cable from the bellcrank. As recommended in AC 43.13-1B, the suspect cable should be removed and inspected for wear and broken wires. It is recommended that the cable be bent as shown in the following illustration to check for broken wires on the interior of the cable.

The state of the cable should be compared against the requirements of the maintenance manual and/or AC 43.13-1B to determine if the cable should be replaced.

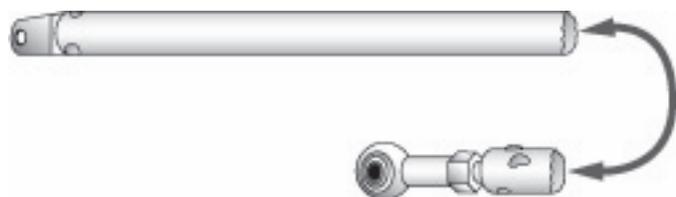
While rigging the N1 fuel system, the technician started to adjust the rod-end bearing (P/N REPB3N-2) on the lower end of the control tube (P/N 206-064-702 001) for the fuel control unit. The control tube broke approximately 1 inch from the lower end. He found corrosion in the interior of the tube, which was not visible until the tube broke. The corrosion appeared on top of the stud that is riveted to the control tube and secures the rod-end bearing. (Refer to the following illustration.)

The submitter stated that there was no visible path for the moisture to enter the tube.
