## ADVISORY CIRCULAR

43-16A

# AVIATION MAINTENANCE ALERTS

**ALERT  
NUMBER  
307**

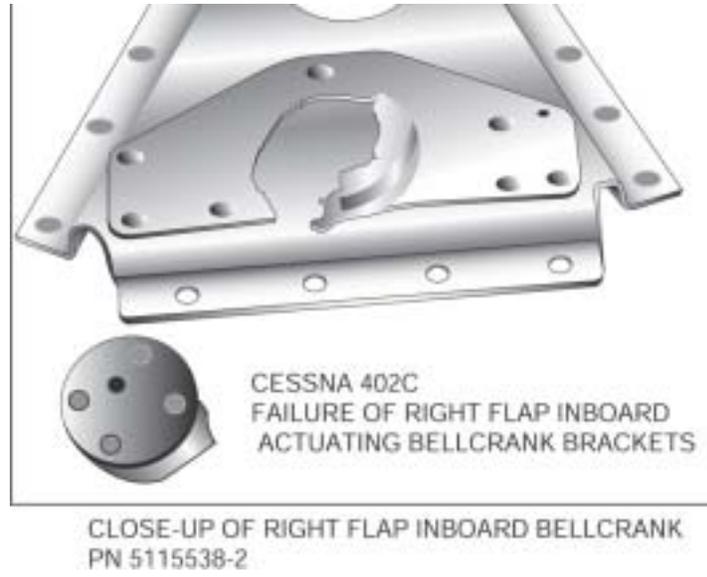
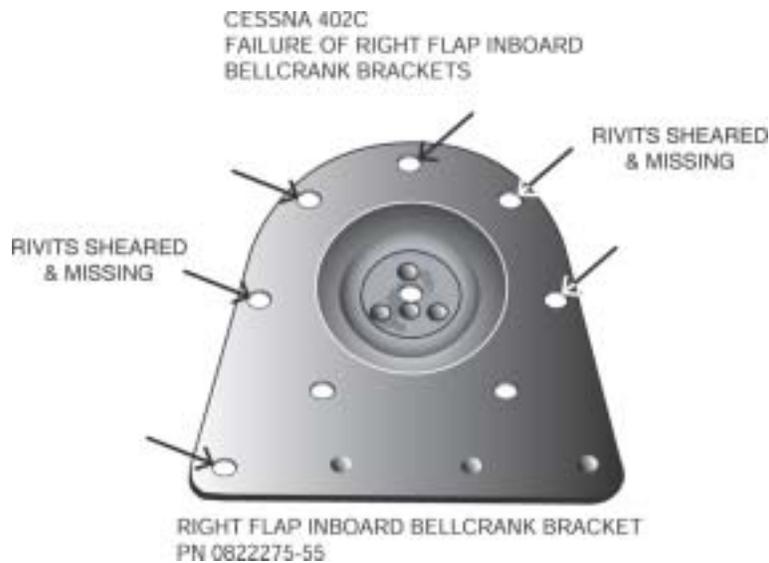
### **Cessna; Model 402C; Businessliner; Trailing Edge Flap Bellcrank Bracket Failure; ATA 2750**

The technician stated that the right flap inboard actuating bellcrank bracket (P/N 5115538-2) failed and caused the flap bellcrank (P/N 0822275-55) to fail. (Refer to the illustrations.)

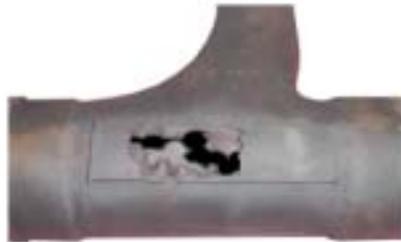
**Cessna; Model 421C; Golden Eagle III; Damaged Engine Exhaust Pipe Riser; ATA 7810**

The technician pressure checked the exhaust system and found a 2-1/2 inch hole at the exhaust data plate on the left inside exhaust riser (P/N 8294-3). The damage was not visible without a mirror.

The submitter believed the cause of this incident was due to uneven heating and cooling of the pipe under the data plate, which is welded to the pipe. (Refer to the illustration.)

The submitter suggested welding the data plate on the outside of the exhaust pipe to allow easier inspections. He also suggested eliminating the data plate and electronically etch information on the riser.
