## ADVISORY CIRCULAR 43-16A

# AVIATION MAINTENANCE ALERTS

ALERT  
NUMBER  
294

JANUARY  
2003

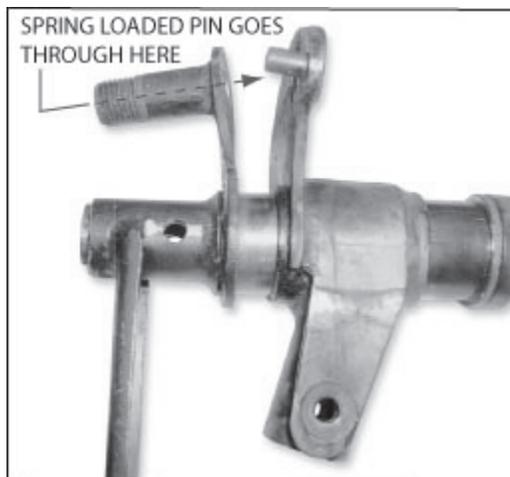
During landing, the CFI was flying the aircraft from the right seat. The aircraft departed the runway to the right, even though the pilot applied full left rudder.

An investigation revealed that the left rudder pedal (Storable Pedals) unlocked when firm pressure was applied. Further inspection revealed the bellcrank (P/N 1260021-1) was bent. (Refer to the illustration.)

The submitter did not have any explanation for why the bellcrank bent.
