ADVISORY CIRCULAR 43-16A

AVIATION MAINTENANCE ALERTS

**ALERT
NUMBER
291**

**OCTOBER
2002**

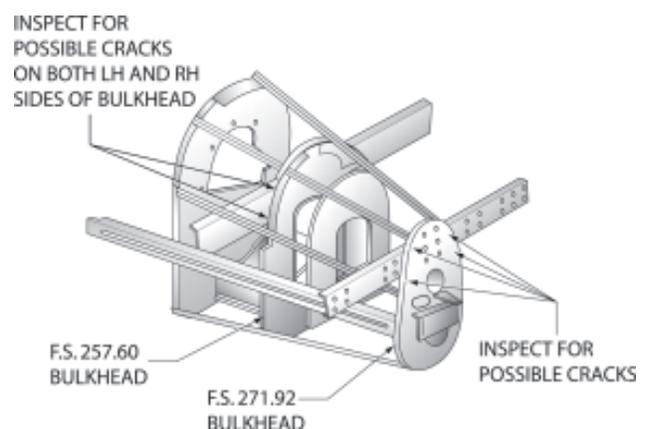
Beech; Model 58; Baron; Fuselage Structural Defects; ATA 5300

During an annual inspection, a technician discovered cracks in the fuselage structure.

The cracks were located in a bulkhead (P/N 002-440023-77) at fuselage station (FS) 257.6. (Refer to the illustration.) These defects are described in Beech, Class I Service Instruction (SI) Number 0990, Revision II. However, SI 0990 is not applicable to this particular aircraft serial number.

Part total time-6,163 hours.

The submitter recommended that the manufacturer research other possible aircraft serial numbers for inclusion in SI 0990.

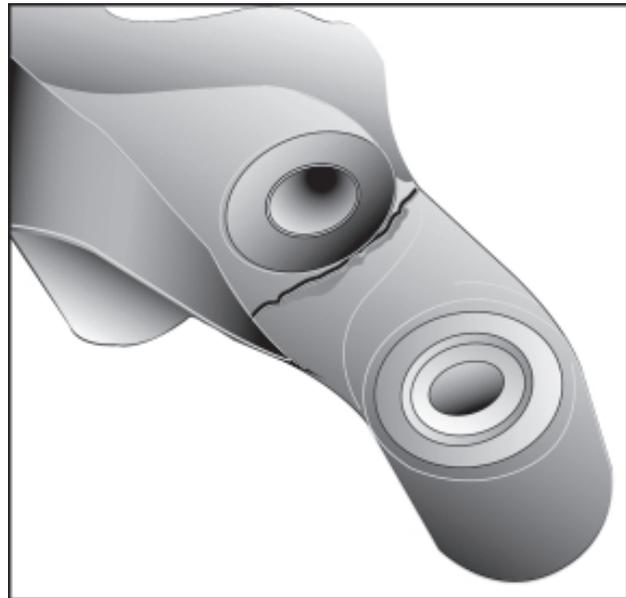
Beech; Model 58; Baron; Air-Conditioning System Defect; ATA 2100

During a scheduled inspection, a technician discovered an air-conditioning system bracket was cracked.

The crack was located on the upper arm of the air-conditioning system compressor bracket (P/N 58-555011-1) on the left engine. (Refer to the illustration.) The submitter stated it appeared the bracket was not shimmed correctly during the previous installation. The crack had progressed to the point of making complete failure of the bracket imminent. He speculated that without proper shimming, the bracket was subjected to preload stress during assembly.

Part total time-94 hours.

The submitter suggested that technicians use the correct shimming technique listed in the manufacturer's technical data.

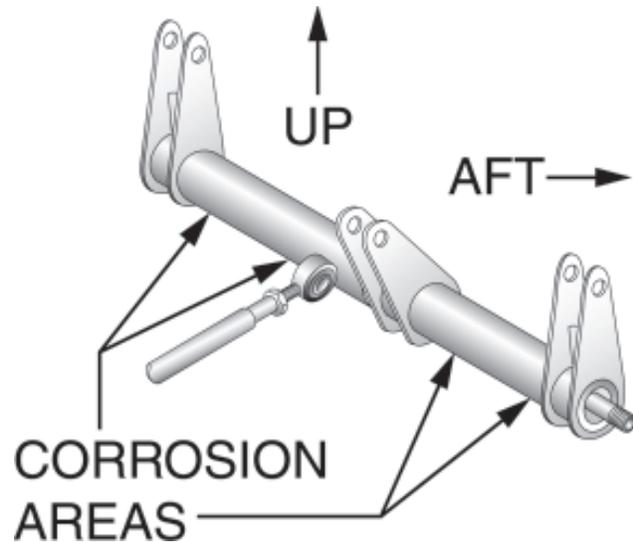
Beech; Model C-99; Airliner; Defective Elevator Control System; ATA 2730

During a scheduled inspection, a technician discovered a serious defect related to the elevator control system.

The technician found severe corrosion in the empennage, which compromised the elevator control. The corrosion had penetrated the elevator bellcrank torque shaft (P/N 115-524046-5) at four locations. (Refer to the illustration.) The torque tube shaft is made of steel, and the corrosion had progressed to the point of impending failure.

Part total time-10,096 hours.

The submitter suggested that technicians use a bright light and an inspection mirror to check the bottom side of the shaft for any sign of corrosion at every opportunity.

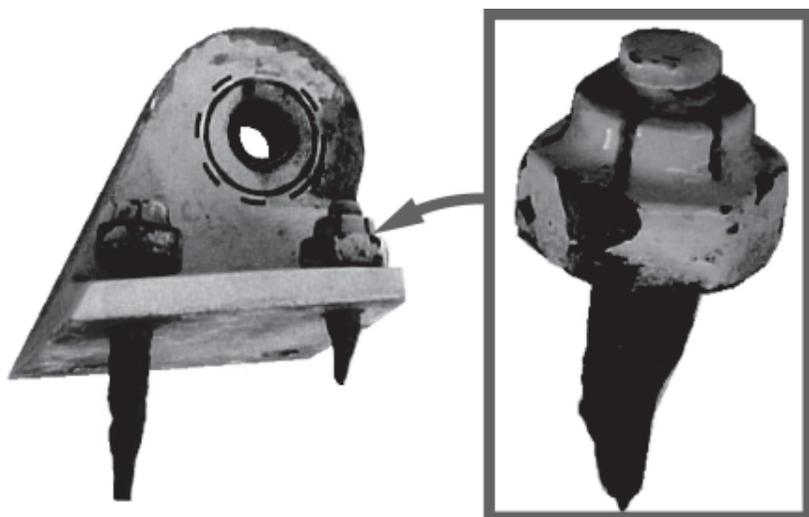
Cessna; Model 414; Elevator Trim System Defective Fasteners; ATA 5523

During a scheduled inspection, the technician discovered the elevator trim tab bearing was "loose" and needed to be replaced.

In the process of changing the bearings, the technician removed the trim tab horn assembly (P/N 0831000-50) which contained the defective bearing. When he applied force to the nuts, the two aft screws (P/N AN515-832R26) broke. The nuts (P/N MS21042L06) used on the two aft screws (P/N MS35206-251) offered no resistance when he removed them. This hardware is proper according to the manufacturer's Illustrated Parts Breakdown (IPB).

Corrosion had completely compromised the two broken screws, which were held in place by a heavy coat of Imron® paint. Approximately 90 percent of the diameter of one screw was corroded and 100 percent of the other screw diameter was corroded. (Refer to the illustration.) The two aft horn attachment screws are enclosed inside the elevator trim tab when installed. The submitter stated it

appears the “foam filling” traps and holds water and other contaminants inside the trim tab and contributes to the defect found in this case.

It is interesting that the Cessna IPB calls for two each of two different types of screws for this installation. Both screw types are nonstructural, have cut threads instead of rolled threads, and have full shank threads. The submitter recommended the manufacturer consider changing these fasteners to a fastener that is designed for structural applications.
